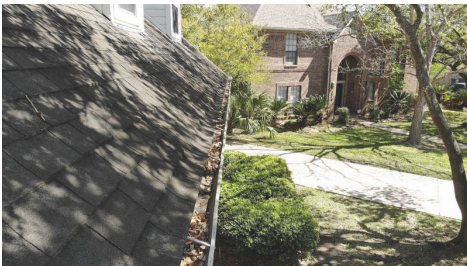
Front

GUTTER FULL OF DEBRIS

Gutter system had debris on one or more locations at the time of the inspection. The inspector recommends that you clean out all debris in the gutters.

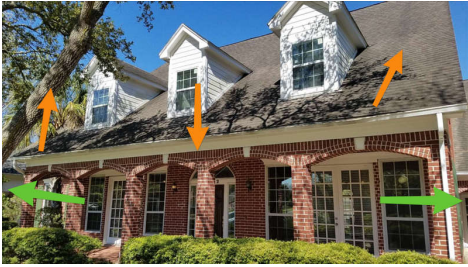
Front

The gutters do not appear to have sufficient slope to drain properly. If they do not perform as intended, the slope should be adjusted.

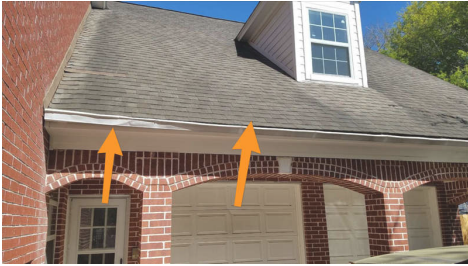
Right, Garage

GUTTER DAMAGED

Damaged guttering was observed.

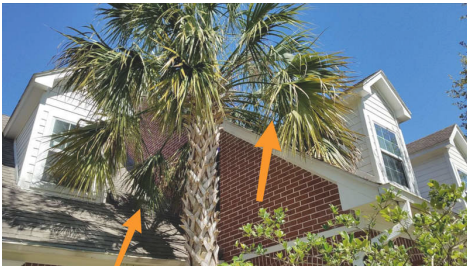
Left Rear

Tree and shrub branches need to be trimmed away from the roofing material at all times to help prevent damage to the roofing material. It is the opinion of this Inspector that there are some branches too close to the roofing material at this time and corrective measures are needed.

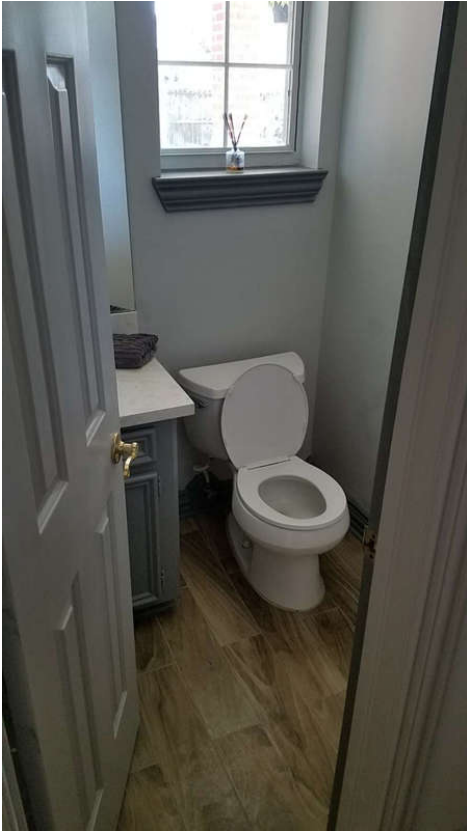
1/2 Bath

One or more doors was found to be difficult to open/close. This is typical after homes begin to settle.

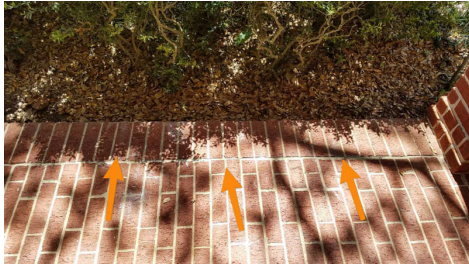
Front

PATIO CRACKS

Some deflection and/or cracking of the patio concrete flatwork was observed.

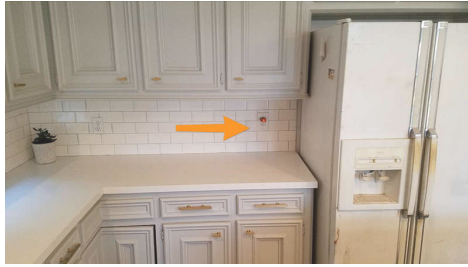
Kitchen

One or more of the ground fault circuit interrupter (GFCI) devices does not appear to be functioning properly at the time of this inspection. Recommend further evaluation by a licensed electrician and repair as needed.

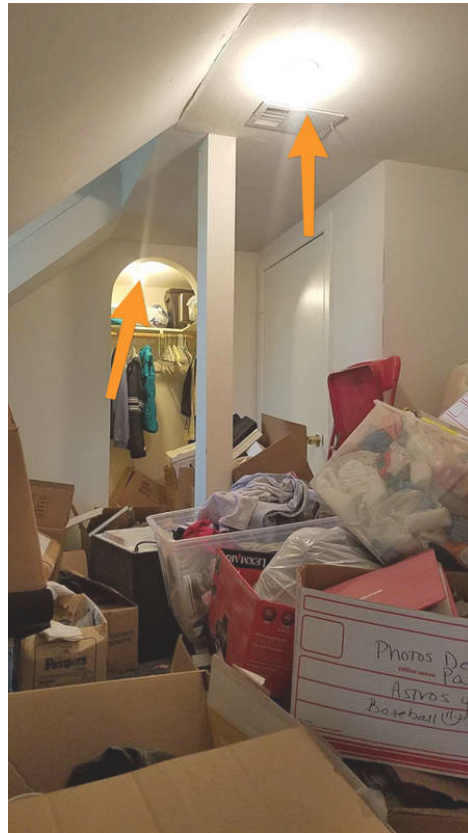
Upstairs Bedroom Closet

One or more of the closet light fixtures appear to be installed without globes and/or covers. Safety precautions should be taken around these light fixtures. This is an as built condition however we are required by TREC to note this as a deficiency.

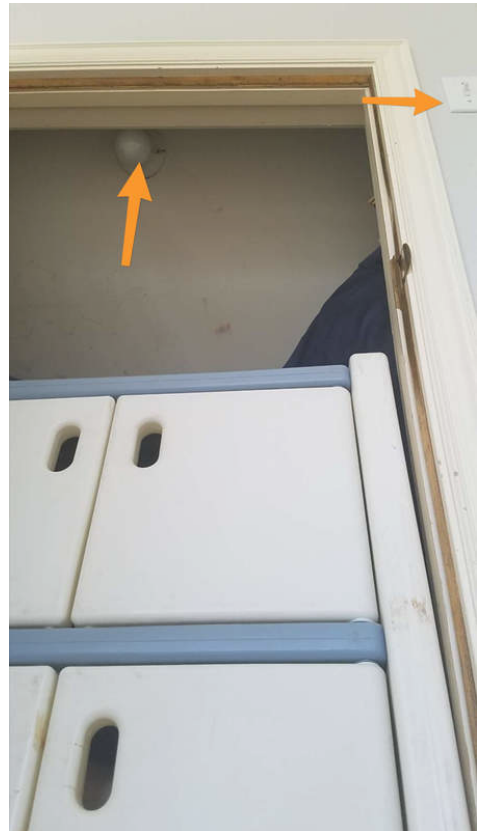
Upstairs Garage apt Closet

One or more of the light fixtures appear to be inoperative. This may be due to a bad bulb or some other unknown condition. This condition should be further evaluated and corrected as necessary.

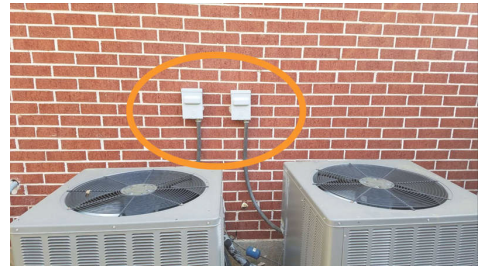
LEFT

The electrical service disconnect is installed behind the outside condenser/coil. This does not meet the clearance requirements of the National Electrical Code or the International Residential Code and should be corrected as necessary.

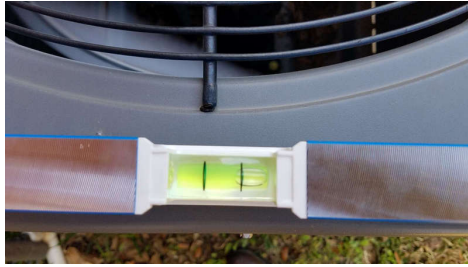
LEVEL OUTSIDE UNIT

The outdoor unit of the air conditioning system is out of level. It is recommended that the outside condenser/coils be within 1-inch of level.

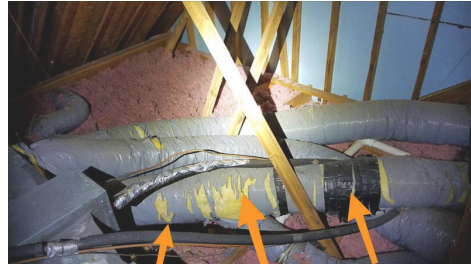
Attic

Ductwork insulated covering was observed to be damaged and/or pulling loose.

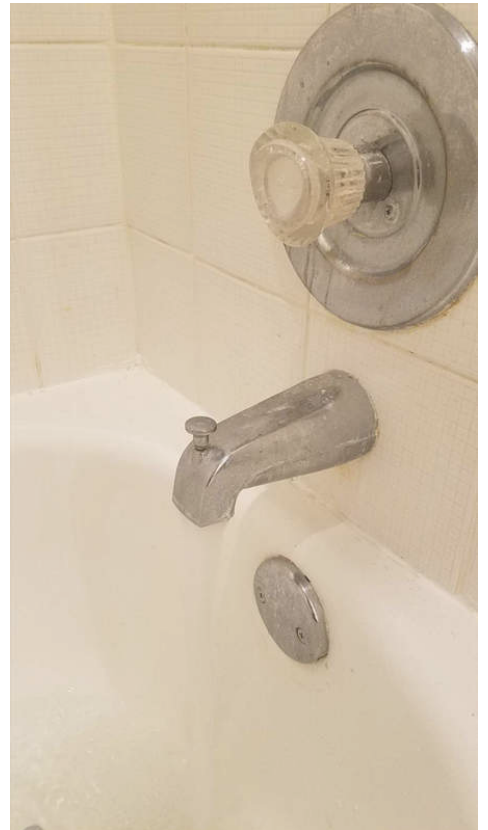
Upstairs Bathroom Left

The bathtub shower head diverter is not functioning properly.

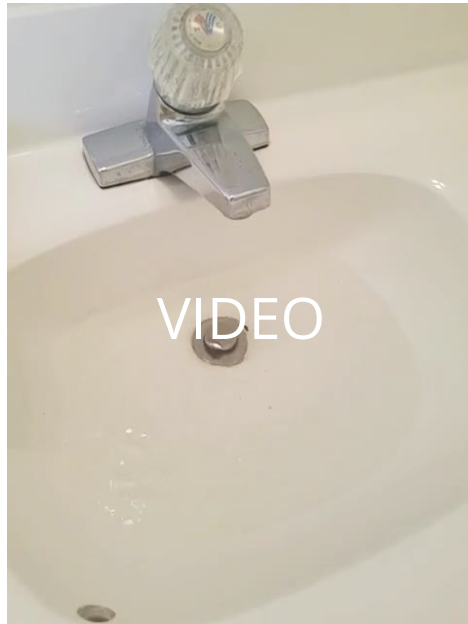
Upstairs Garage apt

SLOW DRAIN = SINK

The sink was observed to drain slowly, suggesting that an obstruction may exist.

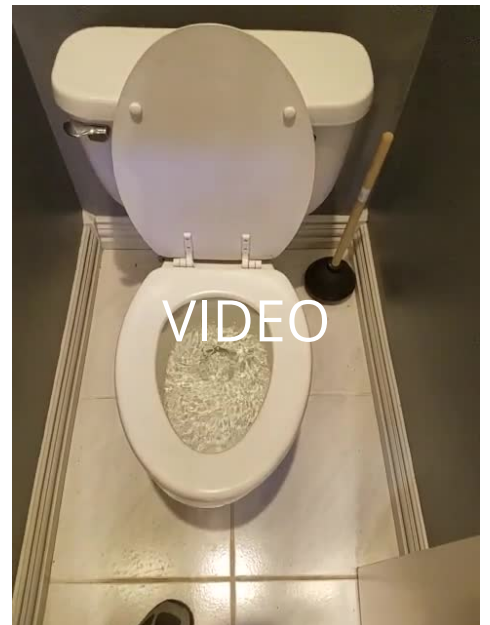
SLOW DRAIN = TOLIET

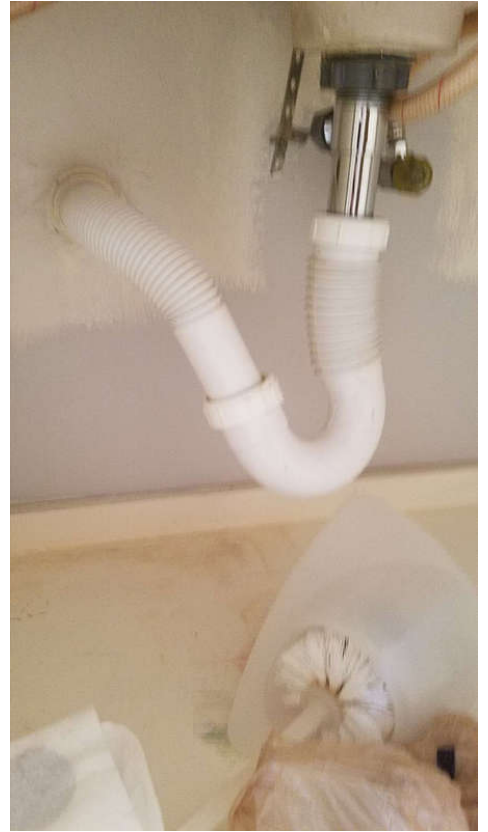
Upstairs Garage apt

IMPROPER DRAIN/WASTE/VENT PIPES

The home contained drain, waste or vent pipes of improper material which should be replaced with pipes of an approved material by a qualified plumbing contractor.

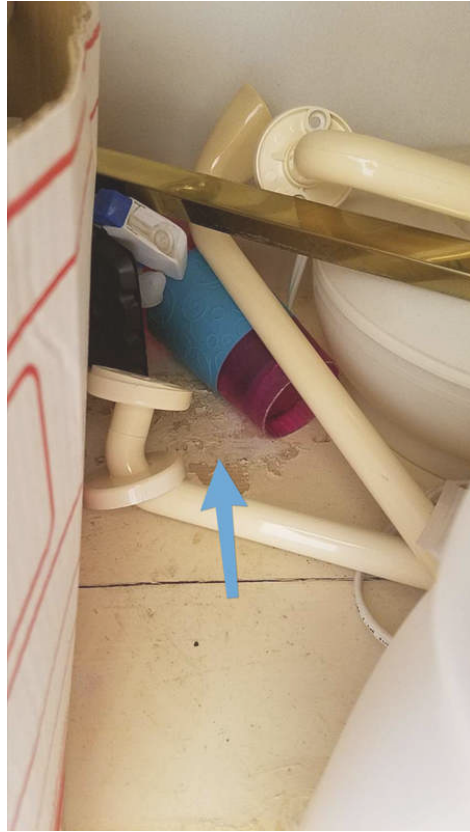
Upstairs Bathroom Left

PRIOR LEAK

Previous water leaks were observed at and/or around the drain connections under the sink. This would indicate previous problems and should be closely monitored and corrected when necessary.

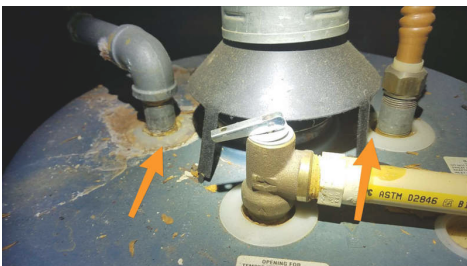
Attic

The fittings at the top of the water heater are made of dissimilar metals (galvanized steel connected to copper and/or brass). It is recommended to replace the galvanized steel fittings with brass or copper fittings or install a dielectric union between the two dissimilar metals to prevent electrolysis from occurring.

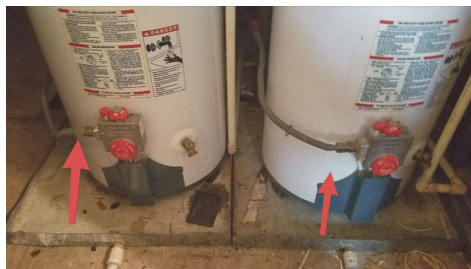
Attic

SEDIMENT TRAP MISSING

A sediment trap should be installed downstream of the equipment's shut-off valve as close to the inlet of the equipment/appliance as possible. Sediment traps (drip leg) are required by today's building standards.

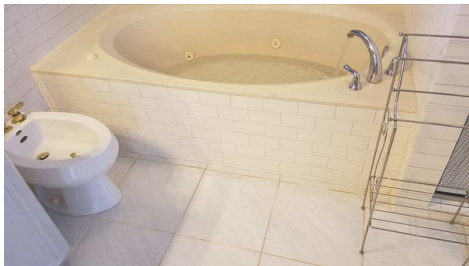
The access to the hydro-massage therapy equipment motor is not readily accessible and inspection of the equipment lines and motor could not be performed. This does not meet current installation standards.

This may be an as-built condition but Per TREC standards of practice we are required to report this condition as a deficiency.

Hydromassage bathtub electrical equipment is required to be accessible without damaging the building structure or finish.

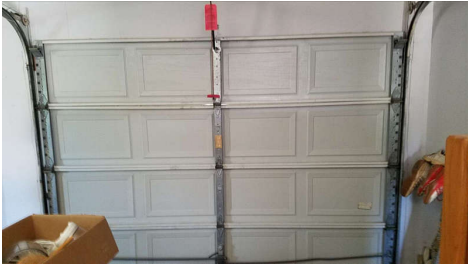
Left

DOOR OPENER NOT OPERATING PROPERLY

The garage door opener does not appear to be functioning properly when operated. The cause and remedy should be further evaluated and corrected as necessary.
