**SUMMARY**  
1234 Main St. Merrimack NH 03054  
Buyer Name  
01/21/2019 9:00AM

Chris Caisse  
InterNACHI Certified...  
Platinum Home Inspections  
603.897.5495

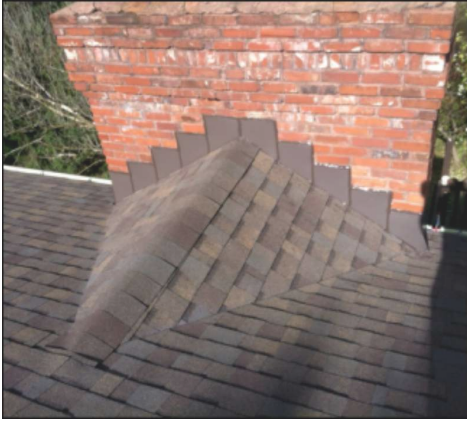
Example #1 of properly flashed cricket.
