SUMMARY
1234 Main St. Merrimack NH 03054
Buyer Name
07/12/2019 9:00AM

Chris Caisse
InterNACHI Certified Professional
Inspector
Platinum Home Inspections
603-897-5495

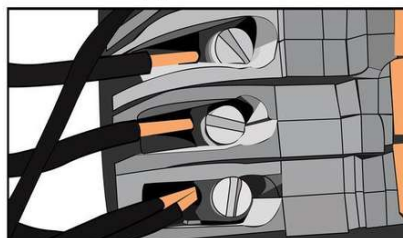
Don't

In the service panel, two wires were connected to a circuit breaker designed for only one wire. This is known as a "double-tap" and is a defective condition that should be corrected by a qualified electrical contractor.

Double-Tapped Breakers

Recommendation
Contact a qualified electrical contractor.
