SUMMARY
1234 Main St. Merrimack NH 03054
Buyer Name
05/15/2019 9:00AM

Chris Caisse
InterNACHI Certified...
Platinum Home Inspections
603-897-5495

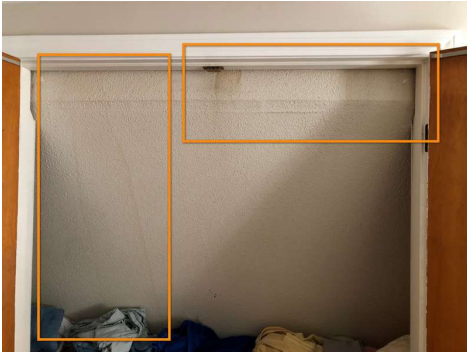
Front bedroom closet. 8.6% is considered present but low.

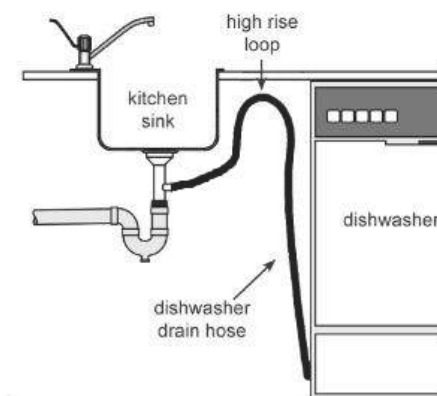
Example

A high loop prevents the dirty water that is being drained from being inadvertently pulled back into the dishwasher or even siphoned back into the water system. Recommend high loop be installed by plumbing contractor.

Recommendation
Contact a qualified plumbing contractor.
