## SUMMARY

1234 Main St. Naches WA 98937

Buyer Name  
01/24/2018 9:00AM

Ryan Franke  
Lic. No. 809  
Integrity Inspection Services LLC  
509-823-1677  
ryan@inspectwithintegrity.com

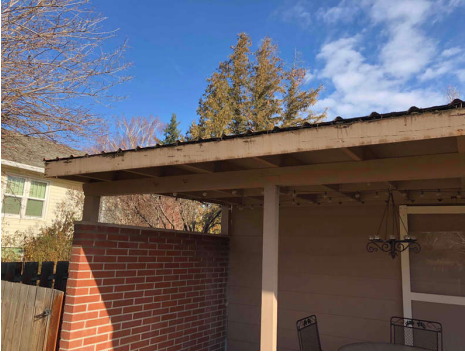
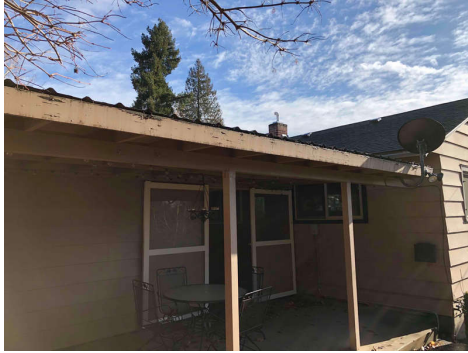
#### **DETERIORATED TRIM**

Moisture damage and deterioration noted at patio cover eaves and sheathing. Saturated trim and ledger boards may trap moisture against structural wood framing causing eventual rot/deterioration and potential structural compromise. Recommend further evaluation by a qualified professional and repair.

Contact a qualified carpenter.

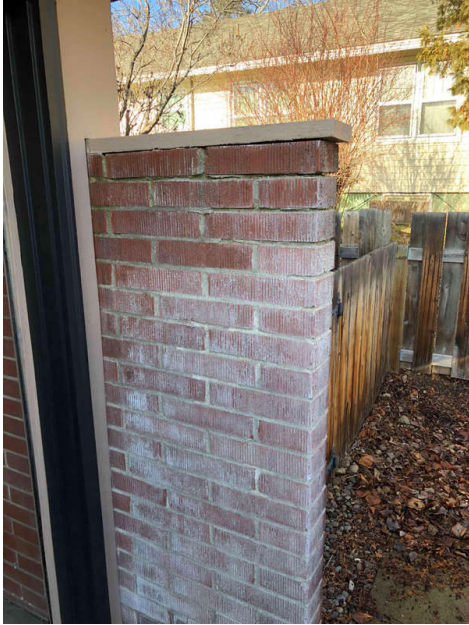
**DETERIORATED MORTAR**

Deterioration at mortar joints may allow for further moisture penetration risking eventual structural compromise and potential loose/falling bricks. Recommend repair.

Recommendation  
Contact a qualified masonry professional.
