SUMMARY

1234 Main St. Beaverton OR 97006

Buyer Name
05/22/2019 9:00AM

Grant Waller
OCHI 1950, CCB 213007
PacWest Home Inspections
503-217-2000
grant@pw-hi.com

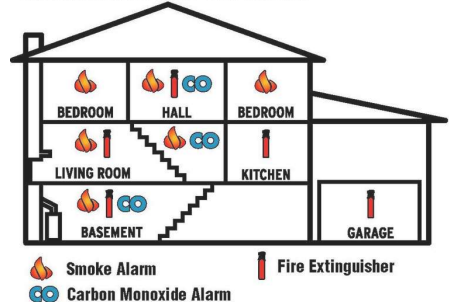
Recommended Locations

A law went into effect requiring carbon monoxide detectors to be installed upon transfer of ownership. These CO detectors are required within 15 feet of all bedrooms and is recommended to have one on each level for additional safety. [Additional Information](#)

Contact a handyman or DIY project
