HOMELOGICS RESIDENTIAL REPORT

1234 Main St. Dunmore PA 18512

HomeLogics Inspection Services, Inc

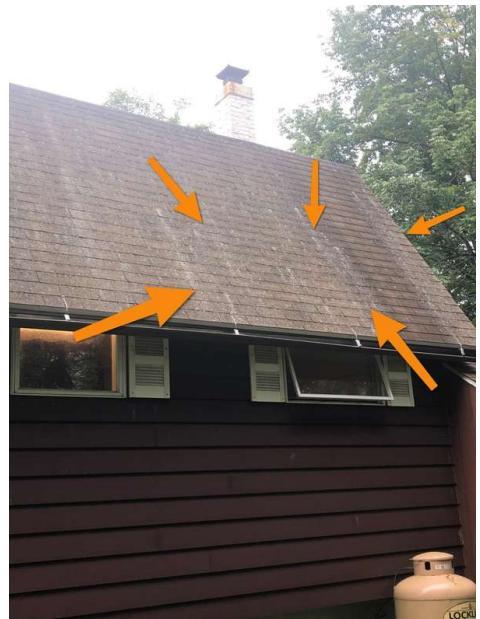
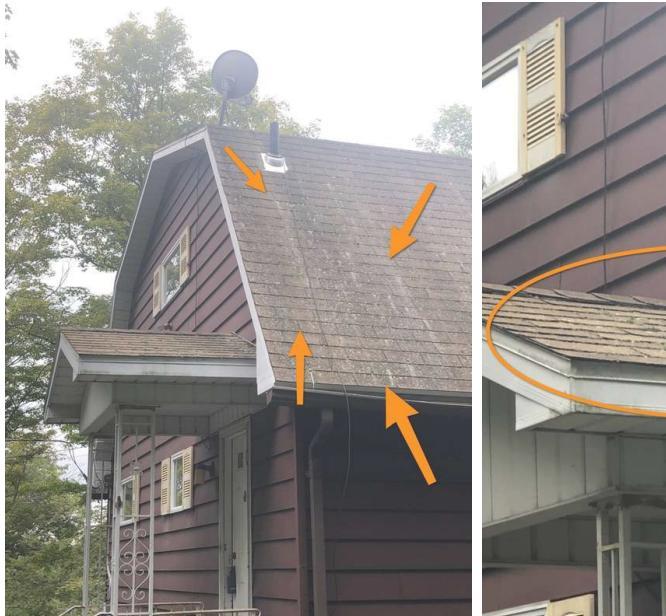
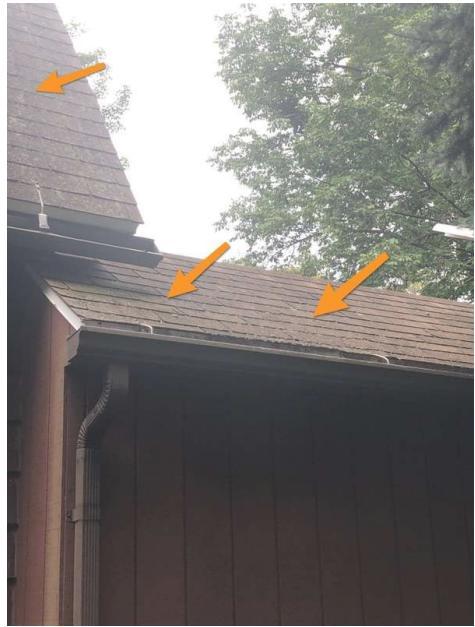
2.1.1 Coverings

ORGANIC MATERIAL

NORTH SIDE OF HOME (PRIMARILY)

By holding moisture against the roof surface, any organic material will speed up the wear of the asphalt shingle surface in freezing climates by increasing frost damage to the mineral granule coating on the shingles. Recommend cleaning of shingles by a qualified roofing contractor.

The source is an algae called Algae-caused marking isn't Gloeocapsa magma. Cleaning may be preventable but can be removed, the most cost-effective solution, since though not always permanently. The it's a fraction of the price of a roof replacement and by feeding on limestone filler

While the dark streaks are unsightly, experts tell our team that the greatest danger to the roof is from moisture retention or root damage that algae and other life forms can cause. Also, algae and fungus can grow together to form lichen, the roots of which can wrap around and feed on the granules covering the shingles. Once established, lichen is not easily removed. Even if it dries out, it can come back to life with the next rain. Scrubbing or power washing lichen will only cause more damage.

Recommendation Contact a qualified roofing professional.

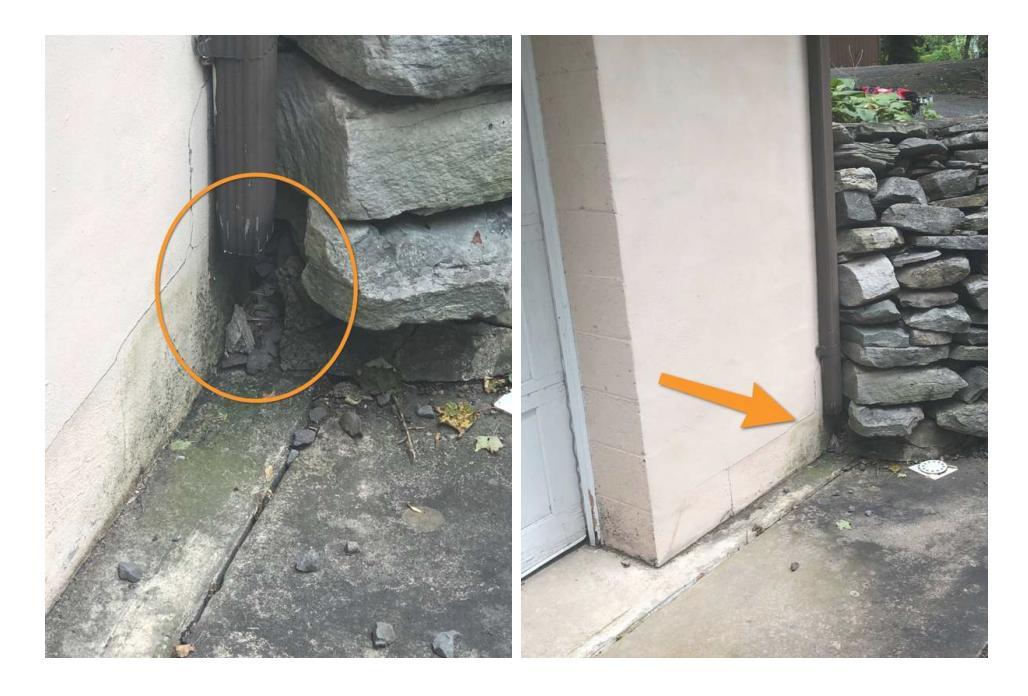
2.2.1 Roof Drainage Systems **DOWNSPOUTS DRAIN NEAR HOUSE**

RIGHT OF GARAGE DOOR

One or more downspouts drain too close to the home's foundation. This can result in excessive moisture in the soil at the foundation, which can lead to foundation/structural movement. Recommend a qualified contractor adjust downspout extensions to drain at least 6 feet from the foundation.

Recommendation Contact a handyman or DIY project

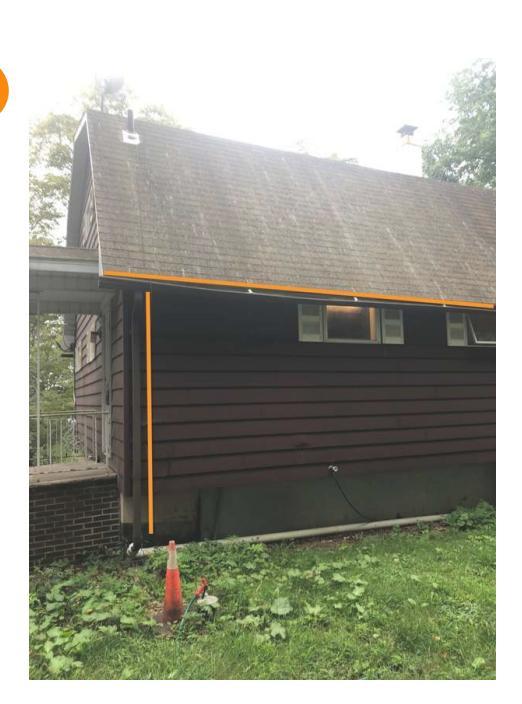
2.2.2 Roof Drainage Systems

GUTTER IMPROPERLY SLOPED

REAR OF HOME

The Gutter is improperly sloped in the rear of the home, which could result in runoff drainage around the foundation and possible structural shifting. Recommend qualified roofing or gutters contractor repair.

Recommendation Contact a qualified roofing professional.

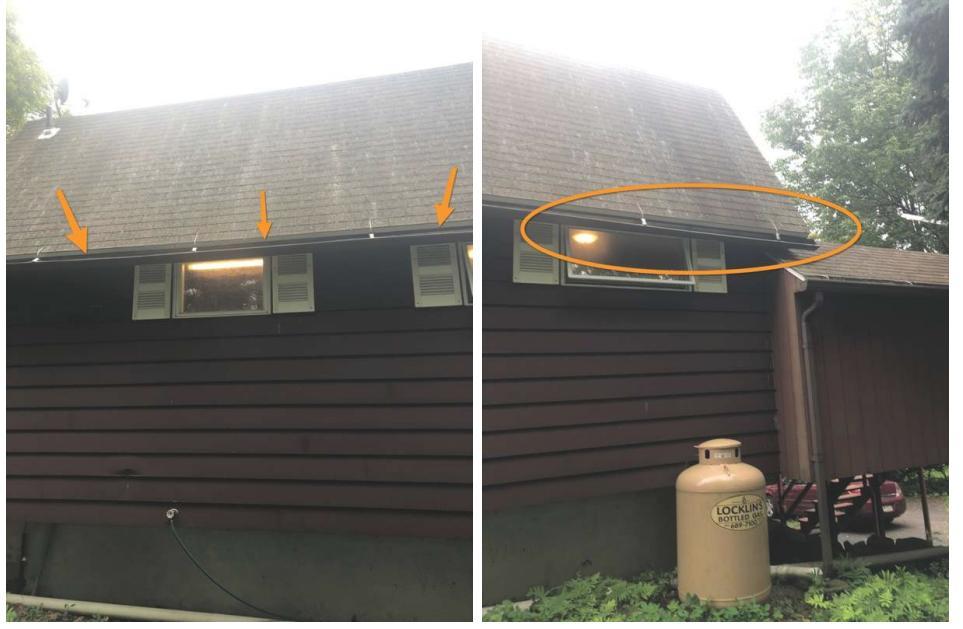
2.2.3 Roof Drainage Systems GUTTER LOOSE REAR OF HOME

The gutter(s) is loose and needs to be re-fastened pitched properly.

The gutter brackets may be reused. Although the gutter was observed to have twisted the brackets appeared to be intact.

Contact a qualified gutter contractor

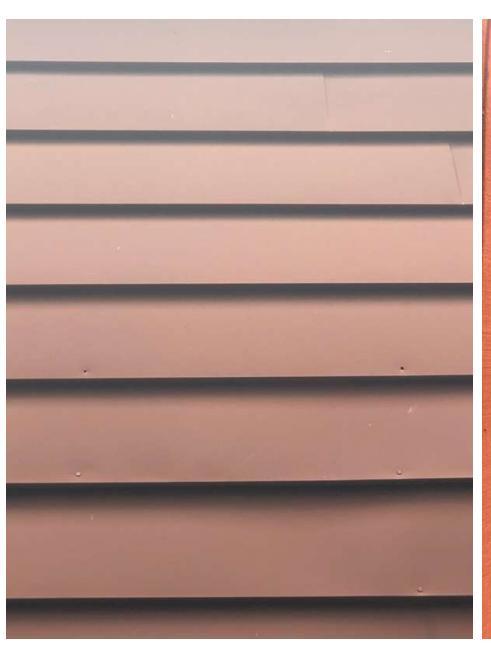
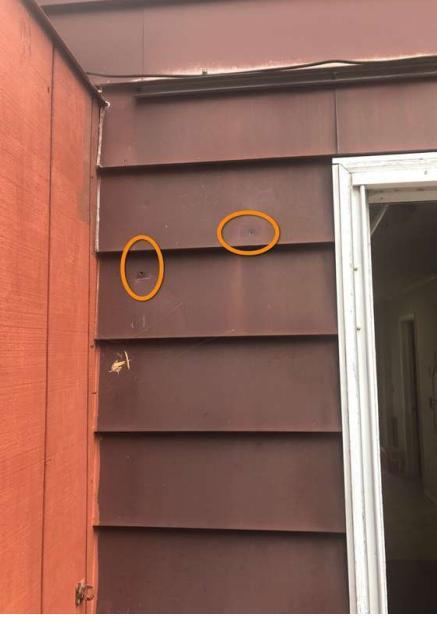
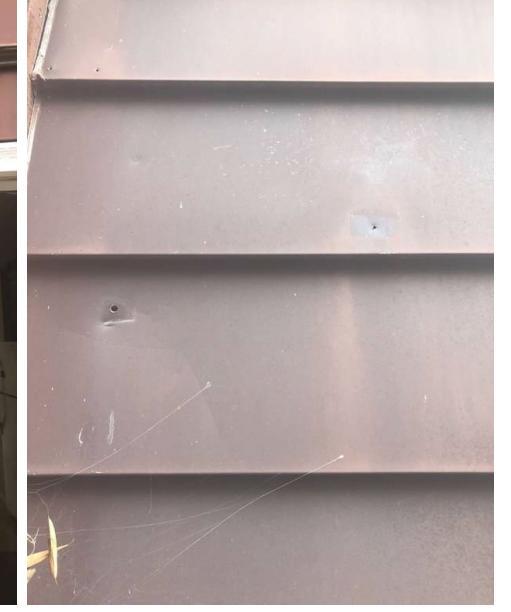
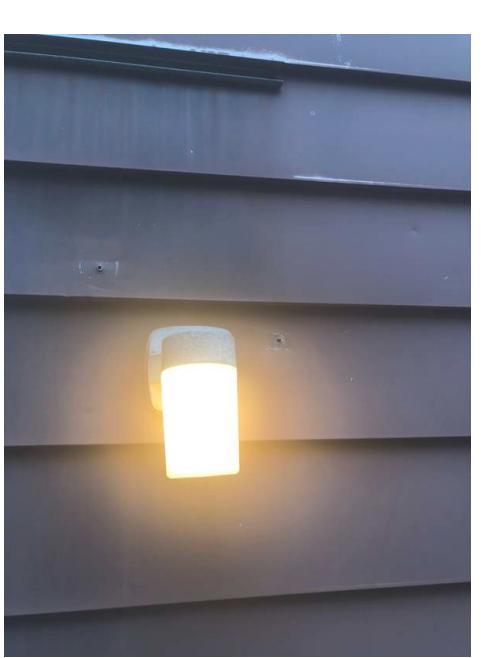
3.1.1 Siding, Flashing & Trim

MINOR NAIL HOLES

THROUGHOUT EXTERIOR (SEE PICTURE DESCRIPTIONS)

Siding showed minor holes in multiple locations. This is a result of nail pop. Recommend caulking or replacing to avoid moisture intrusion or insect infestation.

This location is to the left of the door on the deck.

This location is to the left of the door on the deck. (this is a close up)

Recommendation Contact a handyman or DIY project

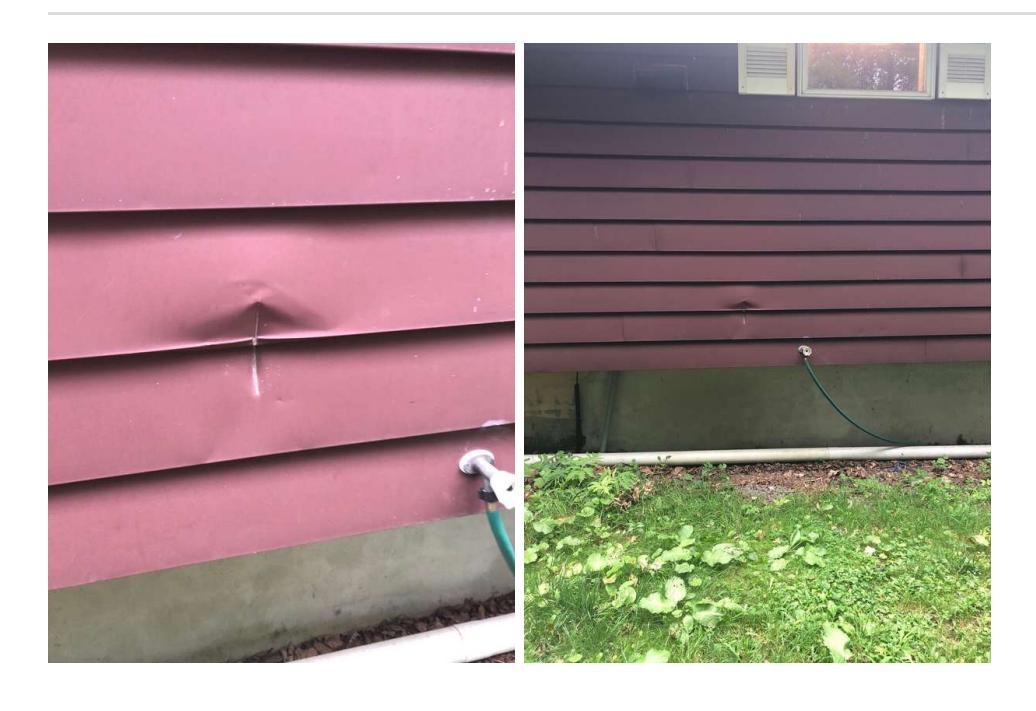
3.1.2 Siding, Flashing & Trim

GENERAL DAMAGE - MINOR

REAR OF HOME

Siding showed signs consistent with landscaping damage. Recommend monitoring for any areas that may allow moisture intrusion.

Contact a handyman or DIY project

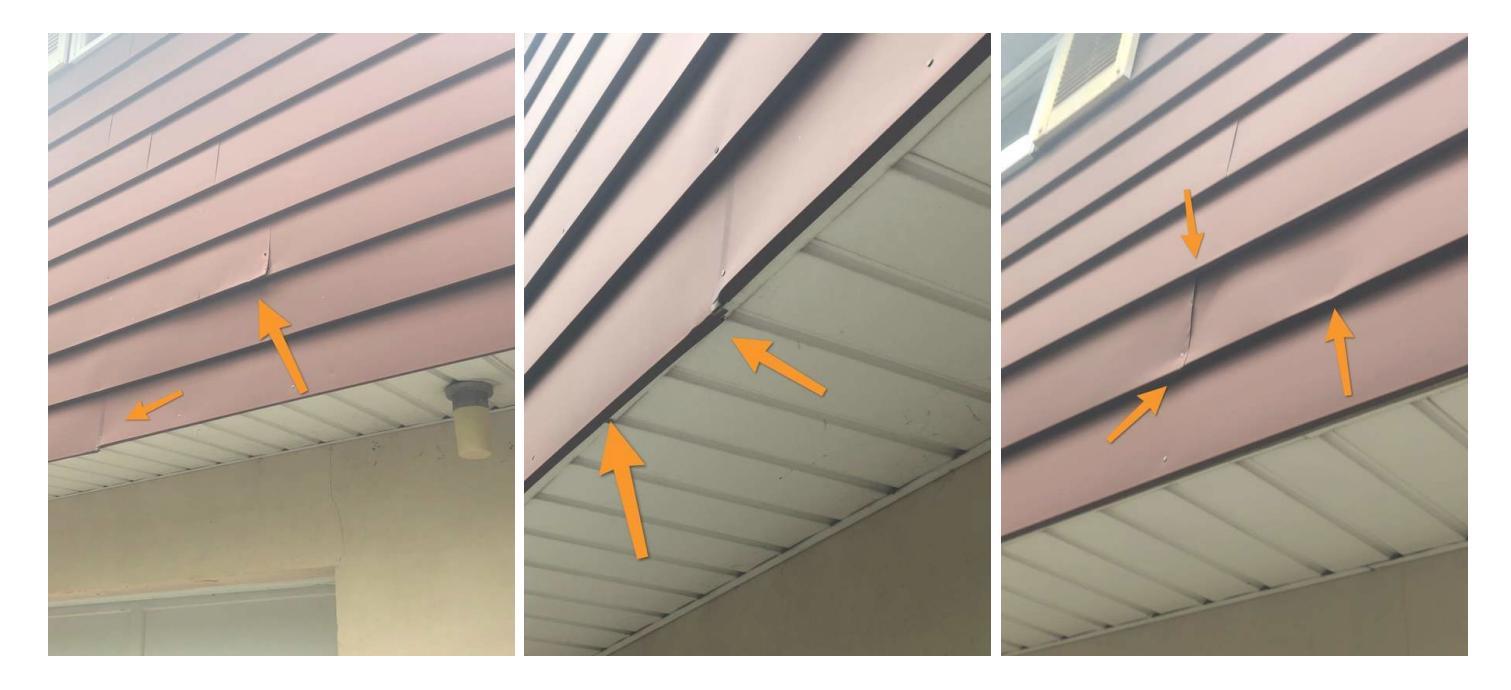
3.1.3 Siding, Flashing & Trim WARPING/BUCKLING

ABOVE GARAGE

Siding was warping or buckling in areas. This is often as a result of nailing siding boards too tight to the home, preventing expansion/contraction. Recommend a qualified siding contractor evaluate and repair.

Recommendation Contact a qualified siding specialist.

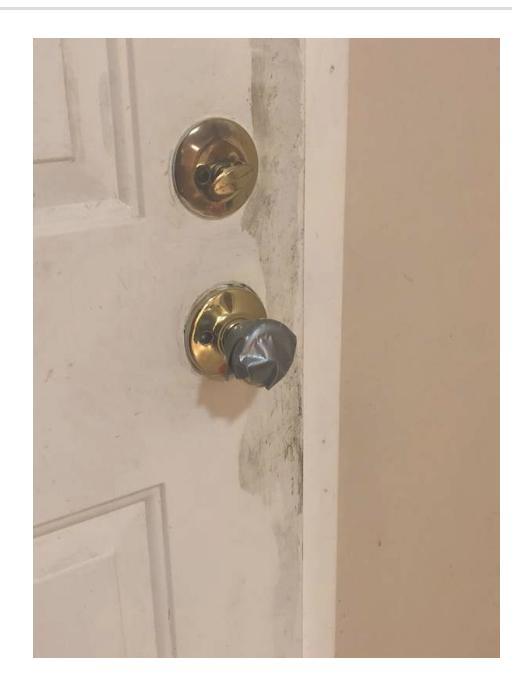
3.2.1 Exterior Doors DOOR DOES NOT CLOSE OR LATCH MAIN DOOR

Door does not close or latch properly. Recommend qualified handyman replace the hardware.

Recommendation Contact a handyman or DIY project

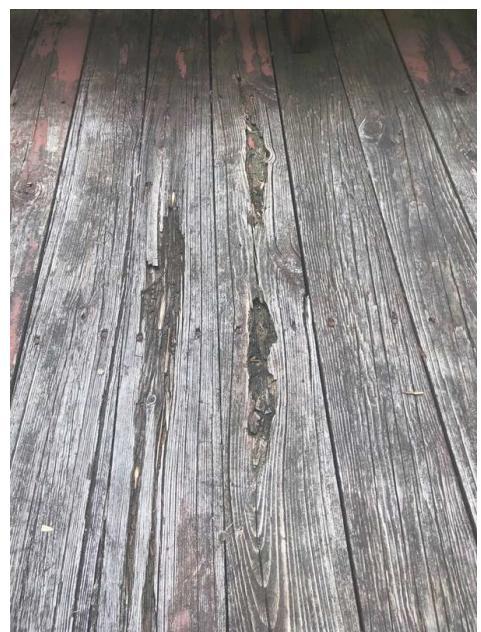
3.4.1 Decks, Balconies, Porches & Steps

DECK - ROTTED BOARDS

DECK

One or more deck boards are showing signs of rot. Recommend a qualified deck contractor replace.

Contact a qualified deck contractor.

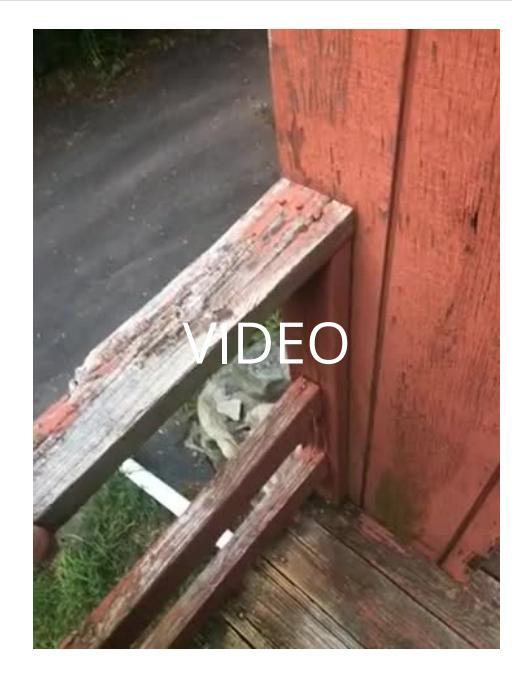
3.4.2 Decks, Balconies, Porches & Steps

DECK - UNSTABLE SUPPORT DECK

One of more areas of the deck support appears unstable. This could cause a safety hazard and further deterioration of the deck. Recommend qualified deck contractor evaluate and repair.

Contact a qualified deck contractor.

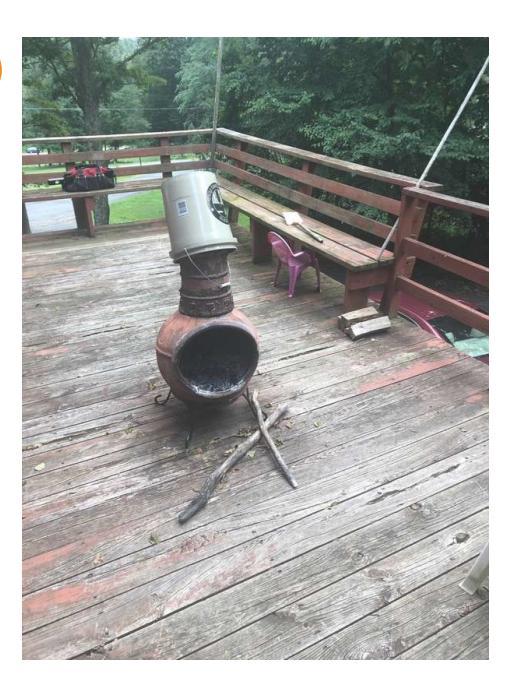
3.4.3 Decks, Balconies, Porches & Steps

DECK - WATER SEALANT REQUIRED

Deck is showing signs of weathering and/or water damage. Recommend water sealant/weatherproofing be applied.

Recommendation Contact a qualified deck contractor. Recommendation

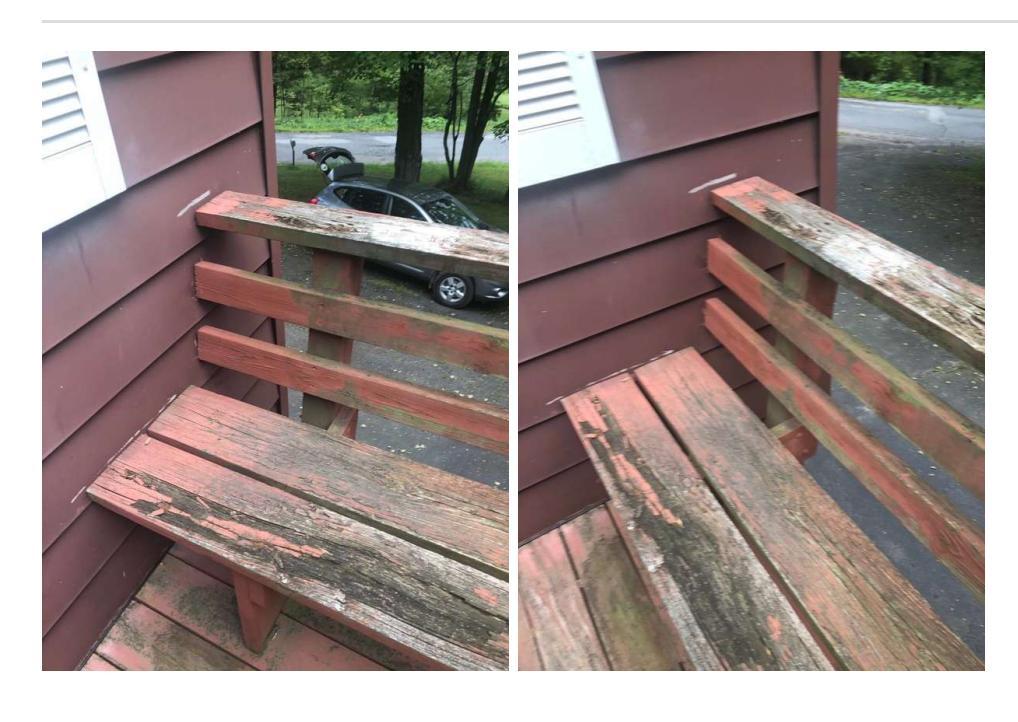
3.4.4 Decks, Balconies, Porches & Steps

IMPROPER DECK CONSTRUCTION PRACTICES

DECK

Deck was observed to have general poor construction. Recommend qualified deck contractor evaluate. Recommendation

Contact a qualified deck contractor.

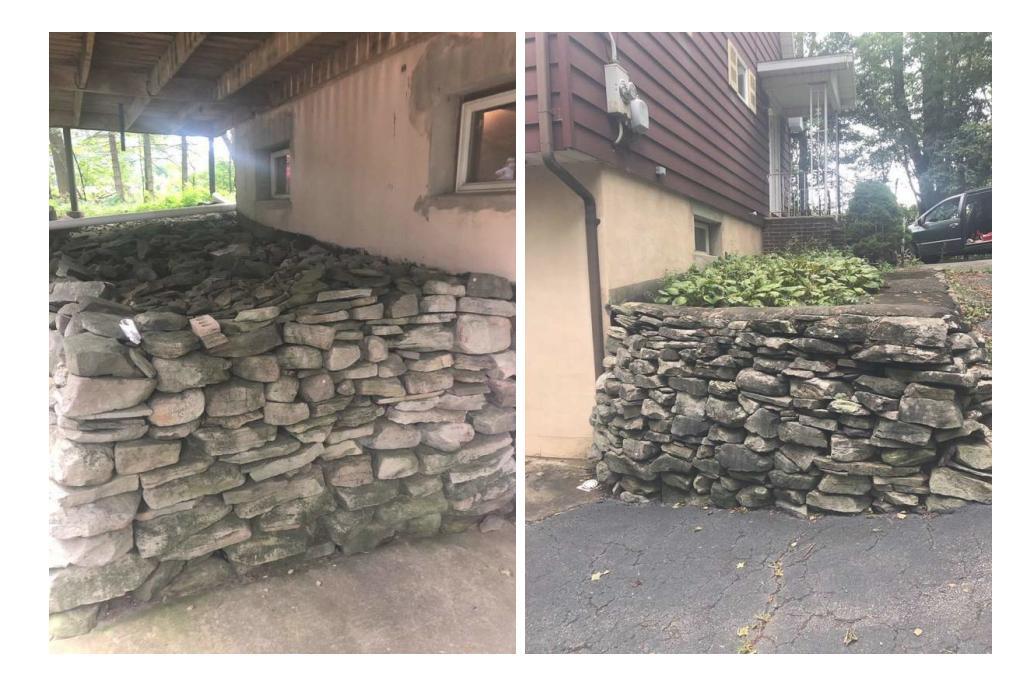
3.6.1 Vegetation, Grading, Drainage & Retaining Walls

RETAINING WALL CRACKS BESIDE FOUNDATION

Retaining wall is showing signs of failing. Recommend qualified contractor evaluate and repair.

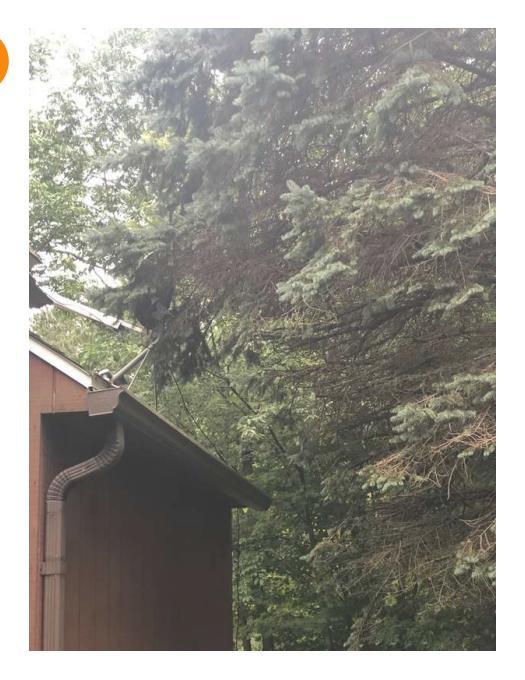
3.6.2 Vegetation, Grading, Drainage & Retaining Walls

TREE OVERHANG

Trees observed overhanging the roof. This can cause damage to the roof and prevent proper drainage. Recommend a qualified tree service trim to allow for proper drainage.

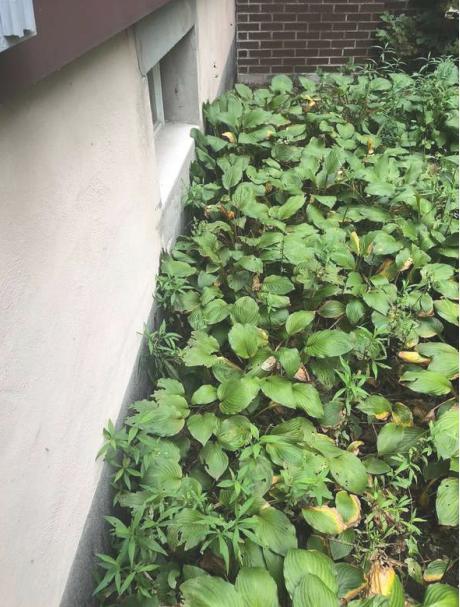
3.6.3 Vegetation, Grading, Drainage & **Retaining Walls**

VEGETATION TOO CLOSE/ IN CONTACT WITH HOME

RETAINING WALL AREA

Moisture held against the building by shrubs keeps the exterior wet and is more likely to allow water inside the home's foundation which can damage structural components and/or create an environment conducive for mold growth.

Additionally vegetation touching the home may allow for insects and rodents, to enter the home. Recommend cutting all vegetation back a minimum of 18".

Recommendation Contact a qualified professional.

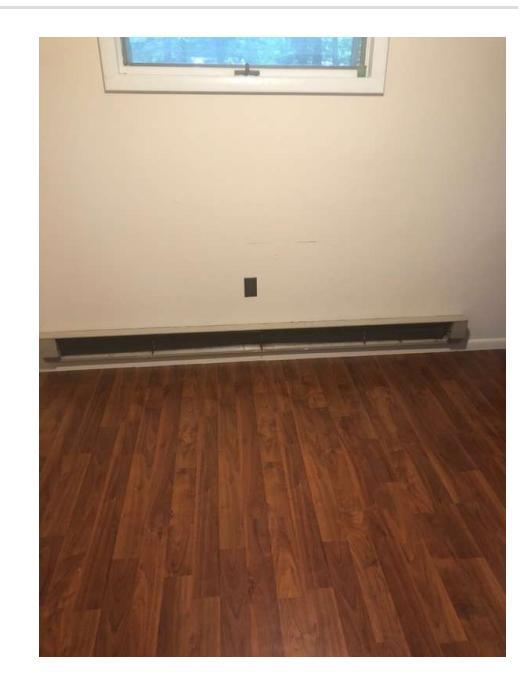
5.3.1 Distribution Systems

BASEBOARD COVER MISSING

DINING ROOM

The baseboard cover was observed to be missing at the time of inspection. Recommend installation of a new one.

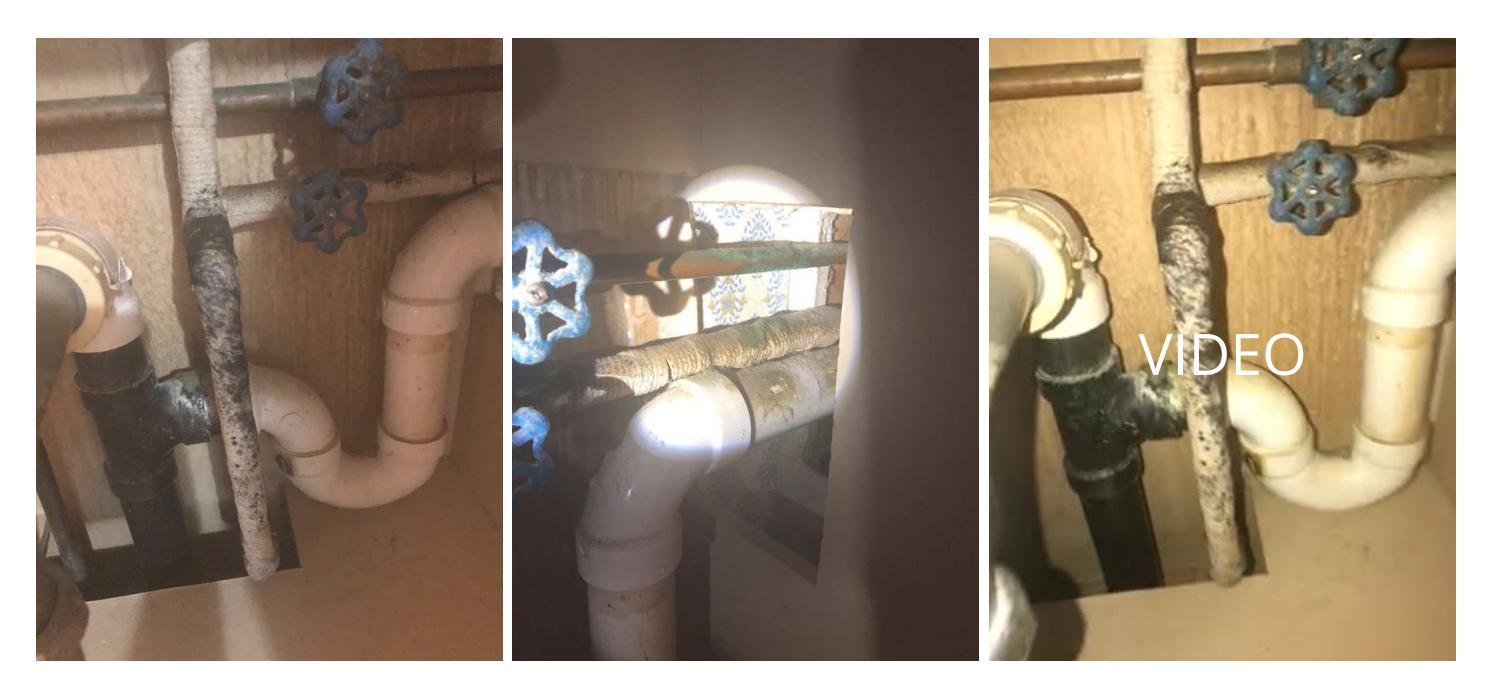
7.3.1 Water Supply, Distribution Systems & Fixtures

PRESENCE OF MOLD

UPSTAIRS BATHROOM

Distribution pipes were observed to be wrapped with a cloth-like material that has grown mold. Avoid using any organic based material in areas of the home prone to moisture as they are more likely to hold moisture. The conditions observed in this location are ideal for mold growth. Recommend removal of the material, cleaning of the area and possible testing by a qualified individual. Mold can be potentially very harmful to certain individuals so this is a safety concern.

Contact a qualified mold remediation contractor

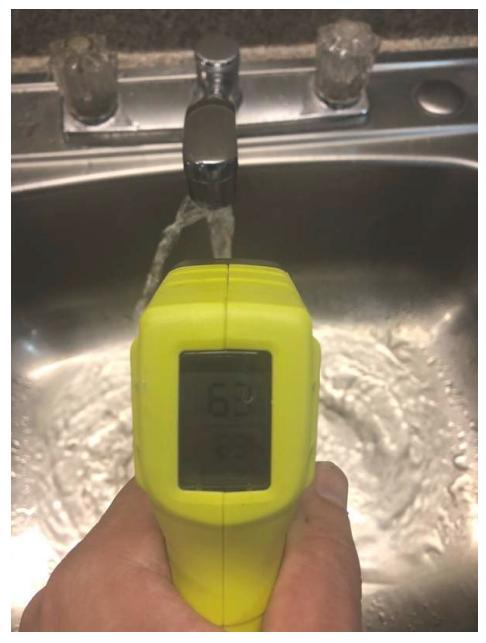
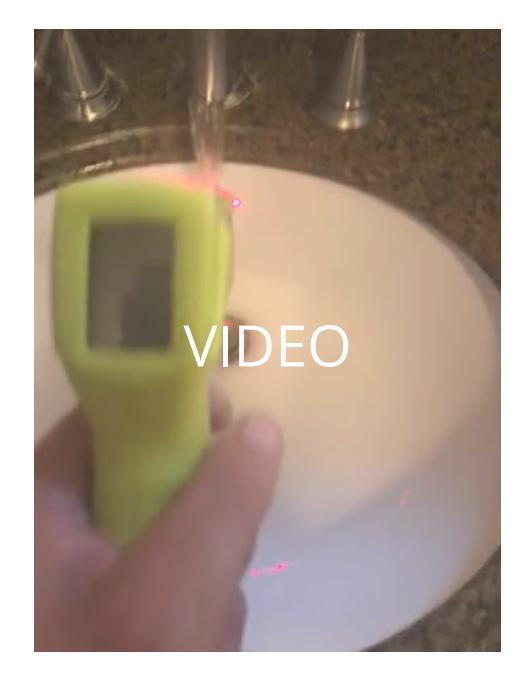
7.3.2 Water Supply, Distribution Systems & Fixtures **LOW WATER TEMPERATURE** KITCHEN SINK/BATHROOM SINK

The water temperature was observed to be too low. Water temperature in a home should be 120 degrees to ensure safety regarding various bacteria while not exceeding 130 degrees to avoid scalding.

Contact a qualified plumbing contractor.

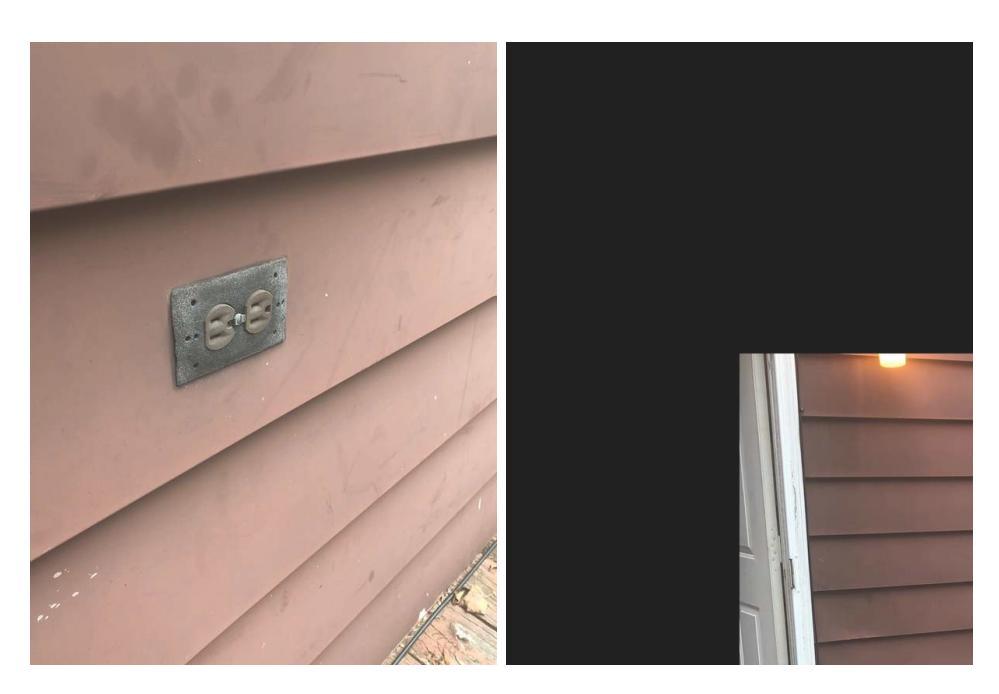
8.4.1 Lighting Fixtures, Switches & Receptacles

COVER PLATES MISSING

EXTERIOR BESIDE DECK

The exterior outlet was observed to be missing a self closing cover plate. The box should be self closing to prevent moisture intrusion in addition to preventing shock hazards.

Recommendation Contact a qualified electrical contractor.

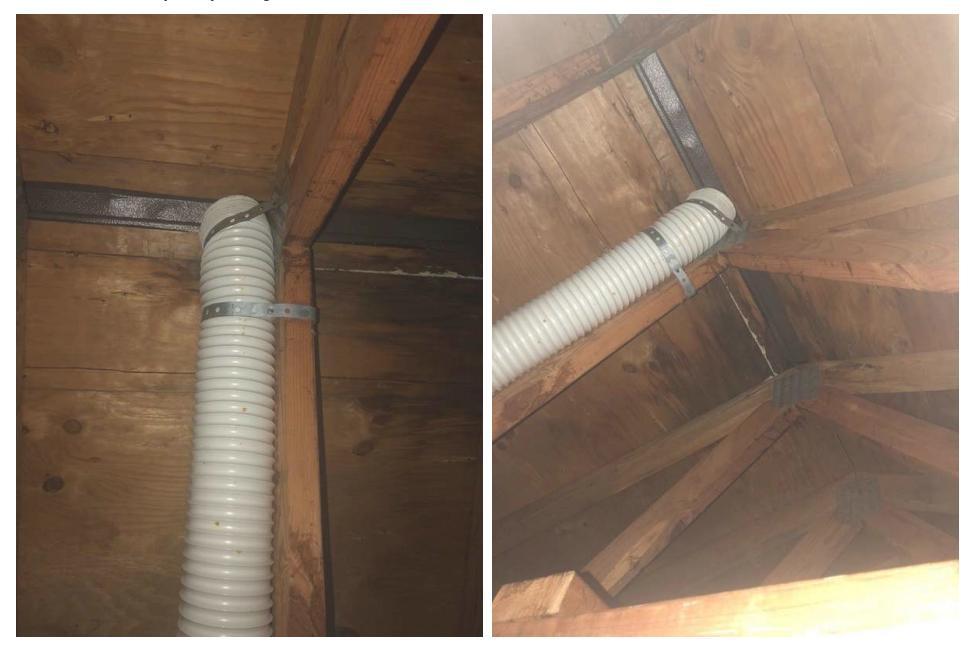
10.4.1 Exhaust Systems BATHROOM VENTS INTO ATTIC

ATTIC

Bathroom fan vents into the attic, which can cause moisture and mold. Recommend a qualified attic contractor property install exhaust fan to terminate to the exterior.

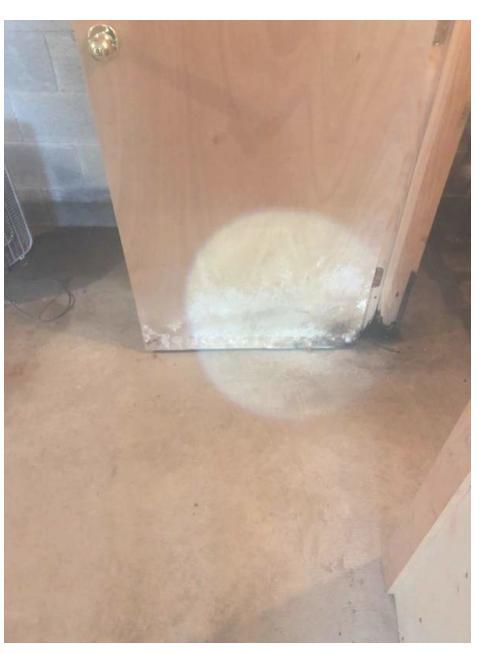
11.1.1 Doors WATER STAINING

GARAGE Door shows noticeable water staining, which could lead to further deterioration. Monitor for future repair or replacement.

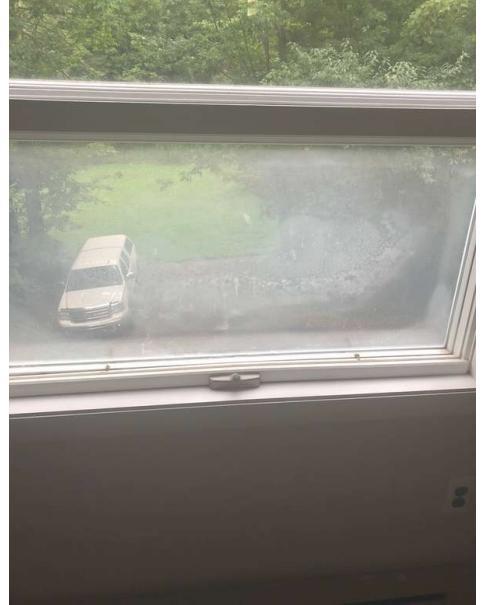
11.2.1 Windows

Observed condensation between the window panes, which indicates a failed seal. Recommend qualified window contractor evaluate & replace.

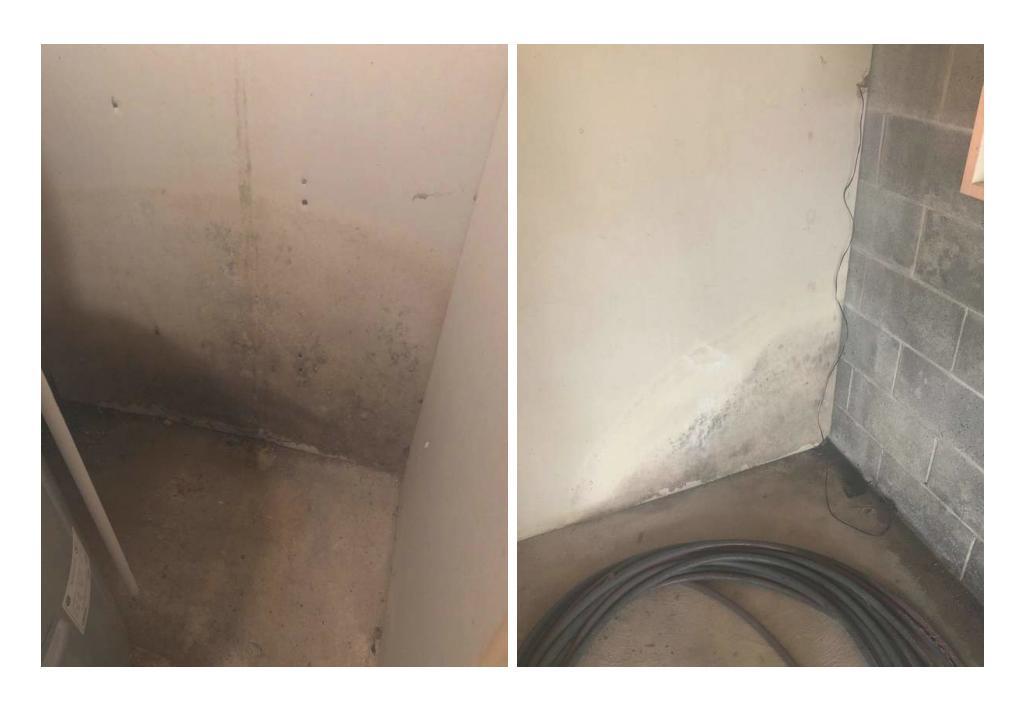
11.4.1 Walls MOISTURE DAMAGE

Stains on the walls visible at the time of the inspection appeared to be the result of moisture intrusion. The source of moisture appears to be the result of the retaining wall located on the other side of the foundation. Recommend further examination by a qualified contractor to provide confirmation.

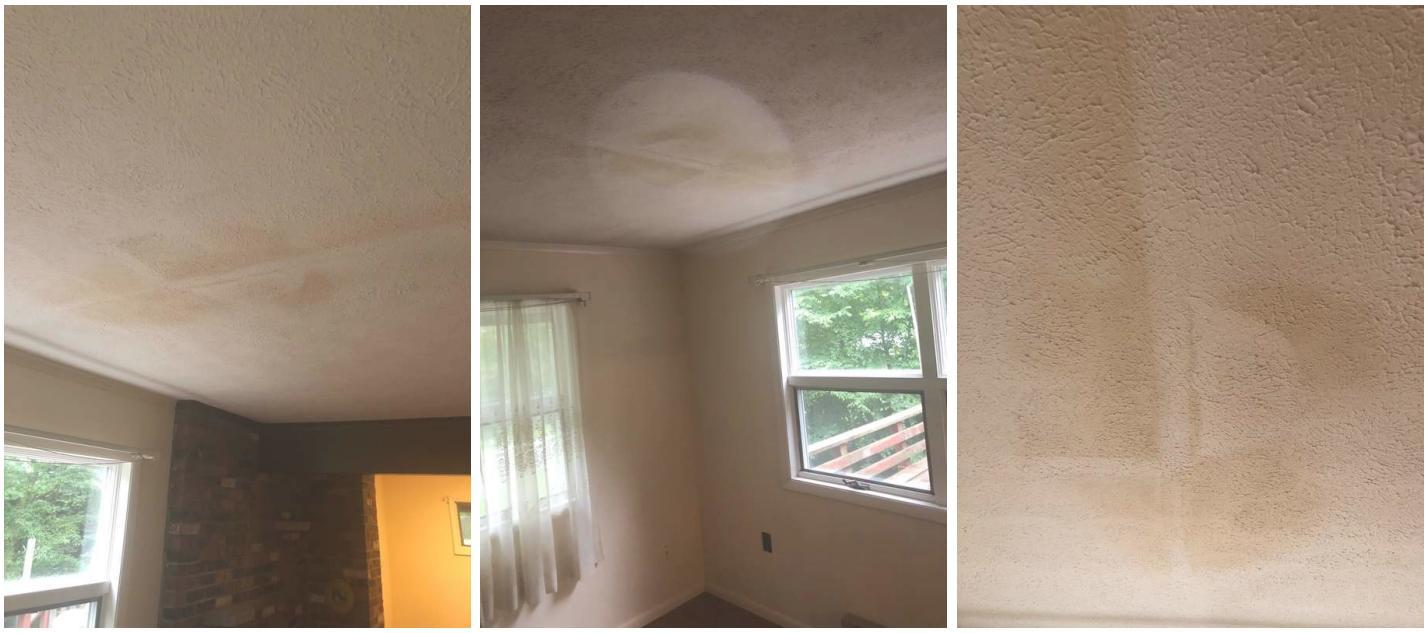
11.5.1 Ceilings STAIN(S) ON CEILING

LIVING ROOM

There is a stain on ceiling/wall that requires repair and paint. Source of staining should be determined however it appears to have been a single occurance and minor in nature as no structural damage has occurred to the ceiling.

Recommendation Contact a handyman or DIY project

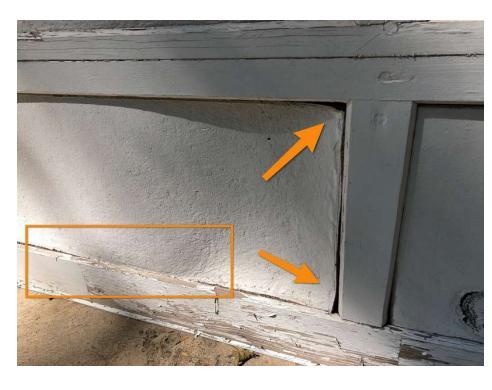
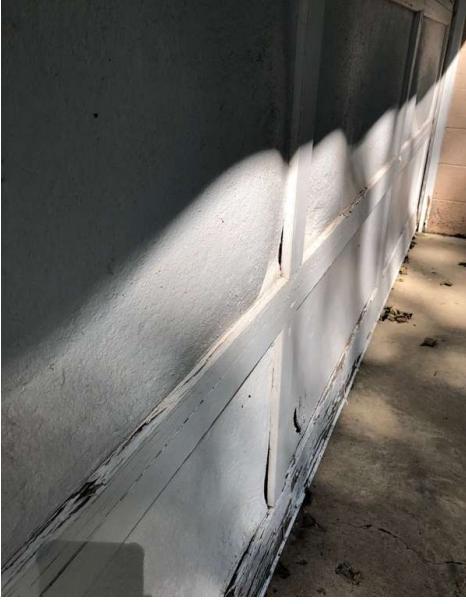
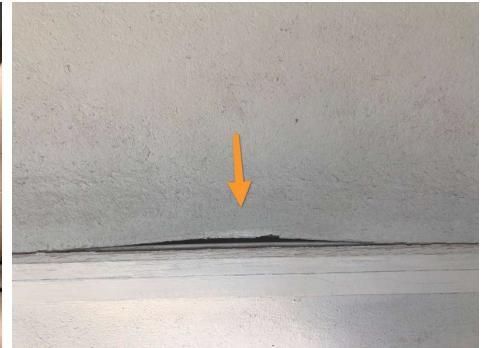
PANEL DAMAGE

Garage door panel is damaged and may need repair/replacement. Recommend a qualified garage door contractor evaluate.

The shadow line should be straight, in this photo the line is highlighting the condition of the door by the visible waviness.
