# Radon Inspection Report

## Measurement of Radon Concentration in Indoor Air

123 Main St  
Pearisburg, Virginia 24134  
United States

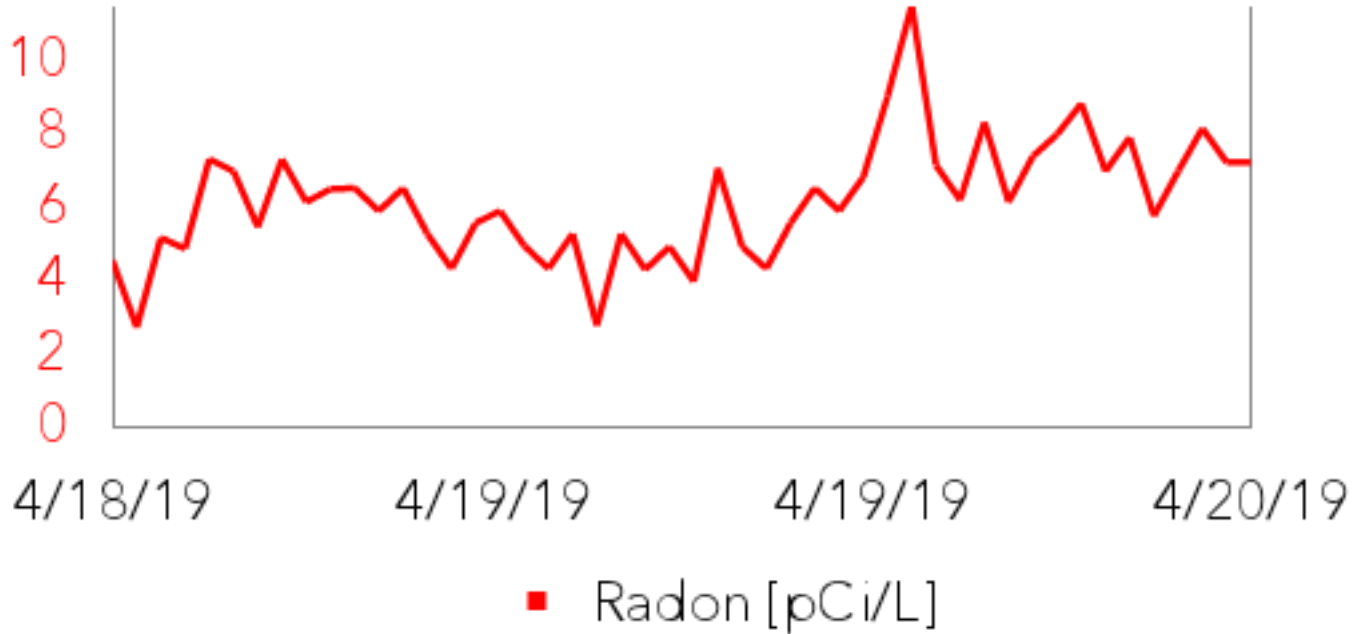
# Radon Chart

Units	Min	Max	Average
Radon [pCi/L]	2.7	11.5	6.1
Temperature [°F]	66.9	73.0	70.9
Humidity [%rH]	47	48	47
Pressure [kPa]	92.53	94.39	93.29
