HOME INSPECTION REPORT

1234 Main St. Colorado Springs Colorado 80920

Buyer Name 10/09/2018 9:00AM

Inspector
Kevin Miller
InterNACHI Certified Home Inspector
(719) 217-9594
premieronehomeinspections@gmail.com

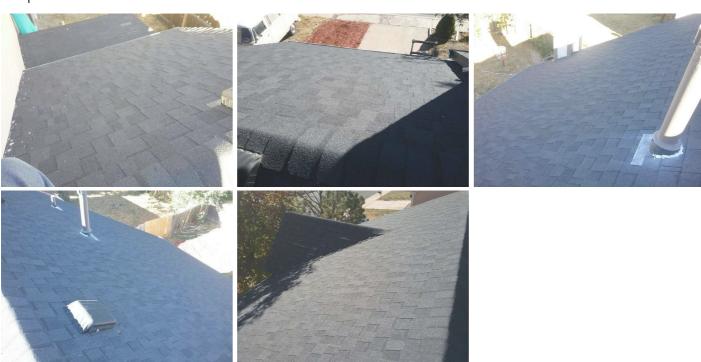
Coverings: Material

Asphalt

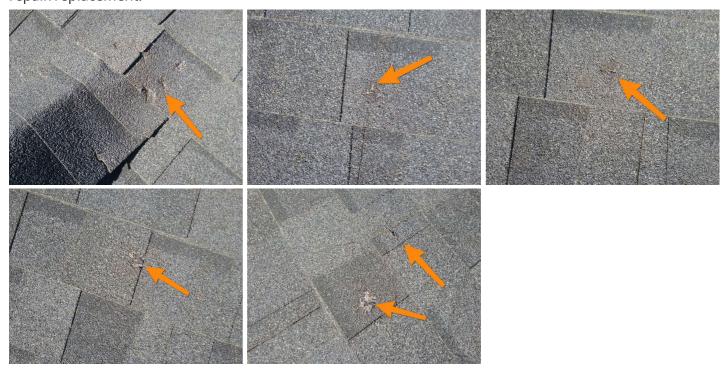
2.1.2 Coverings

DAMAGED - MODERATE

Roof coverings showed moderate damage. Recommend a qualified roofing professional evaluate for repair/replacement.
