## RESIDENTIAL HOME INSPECTION

1234 Main St.  
Wellington 6022

Buyer Name  
10/27/2018 9:00AM

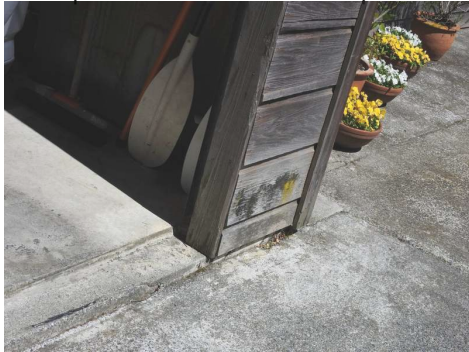
Example of a recommended product.

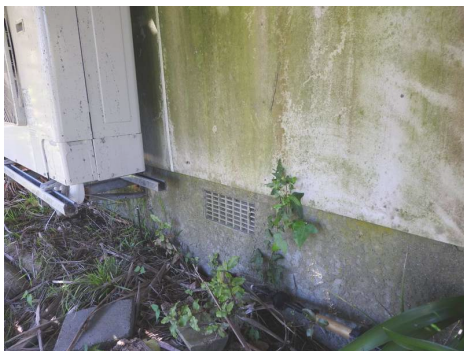
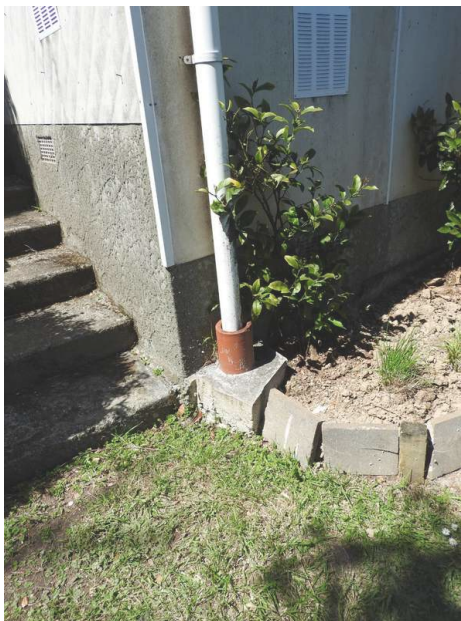
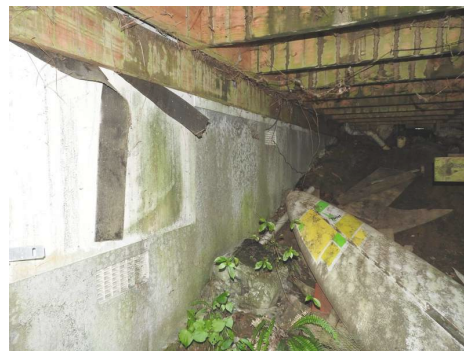
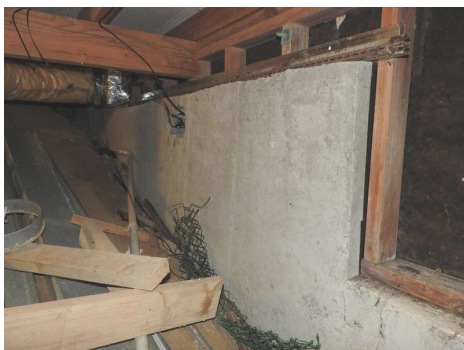
### Concrete ring foundation: Inspected

This foundation appears to be solid and standing true.No obvious sign of cracking or subsidence. Has great allowances for ventilation.

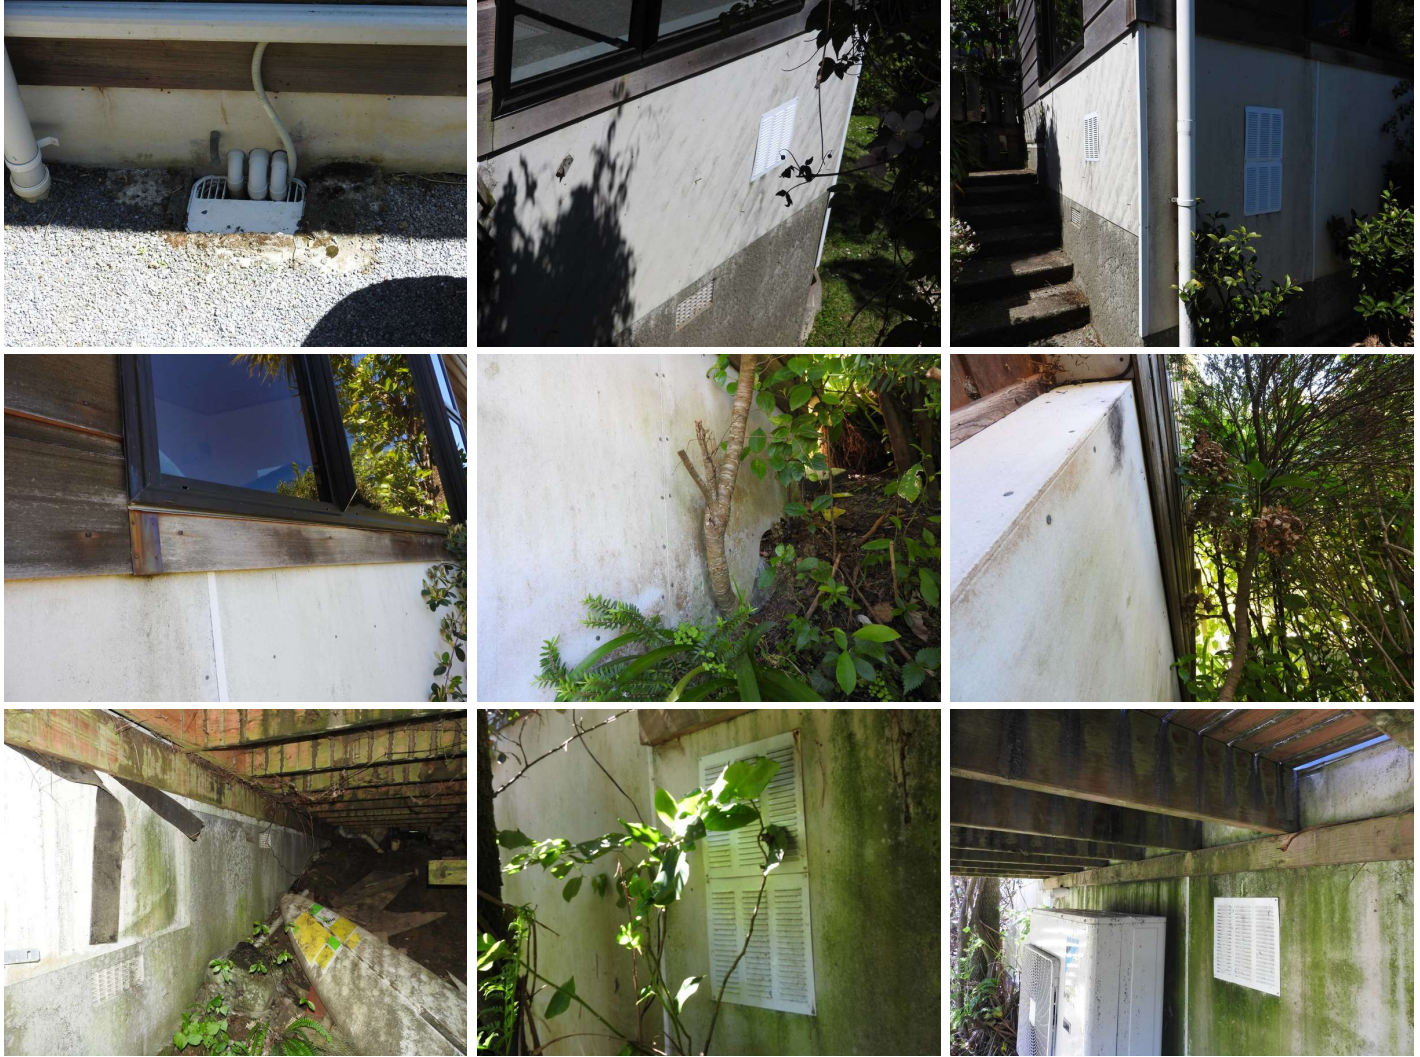
**Fibre cement sheet product: Inspected**

See note on ACM below

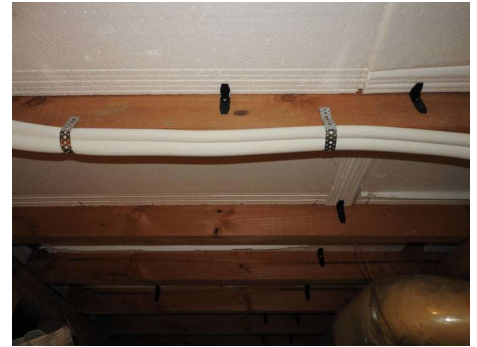
**Subfloor Space: Insulation : Type and condition assessment**

Polystyrene, Good condition

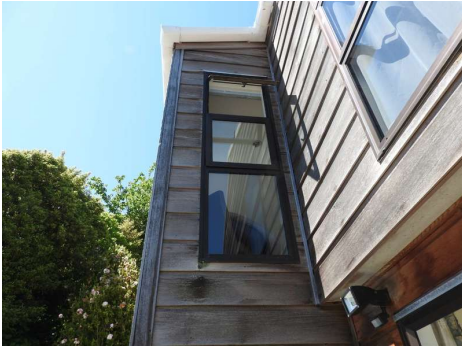
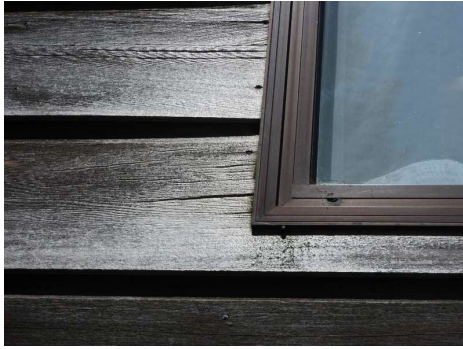
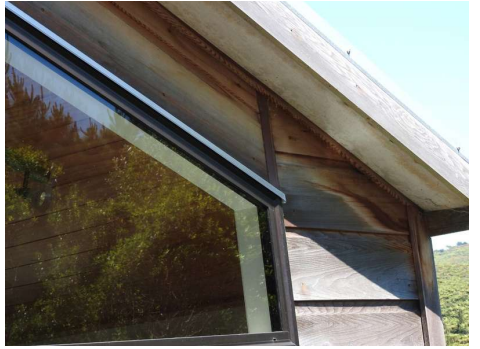
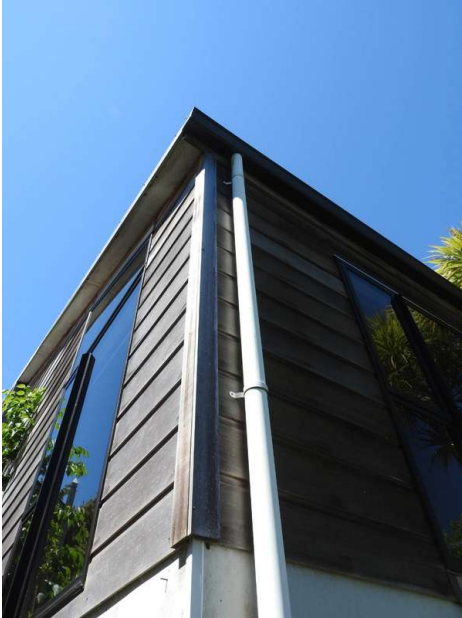
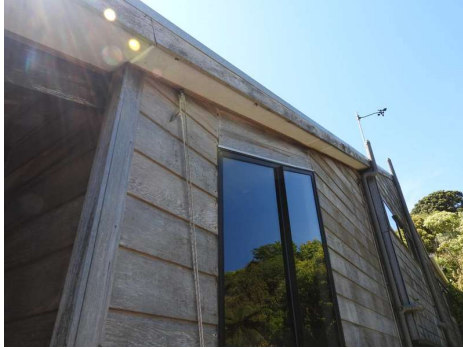
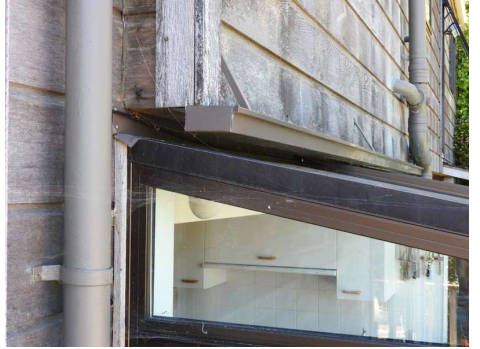
The retrofitted double glazed windows - with the added weight of the double glazing this may cause the window joinery to sag where these are installed as new. modern windows would have WANZ bars installed into the framework to account for the extra weight. This is showing on the bay window in the kitchen, you can see the weight of the roof and the window has dropped and it's putting stress on the joins.

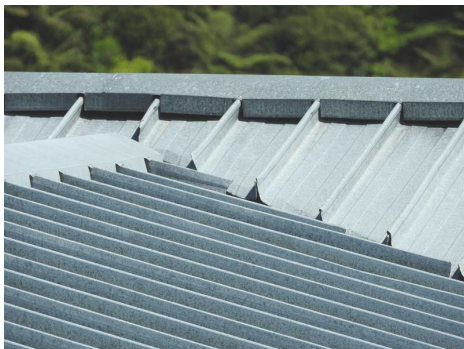
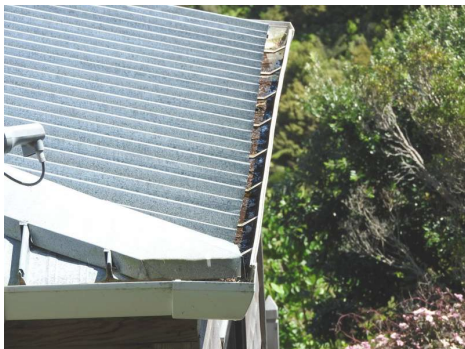
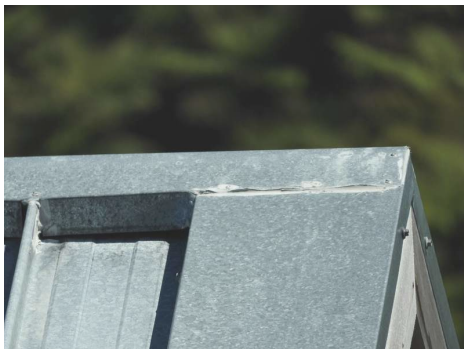
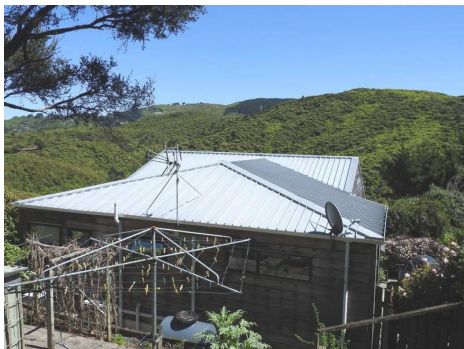
Unfortunately inspecting the roofspace for evidence of leaking is not possible on a skillion roof as by design there is no roofspace, it's enclosed.

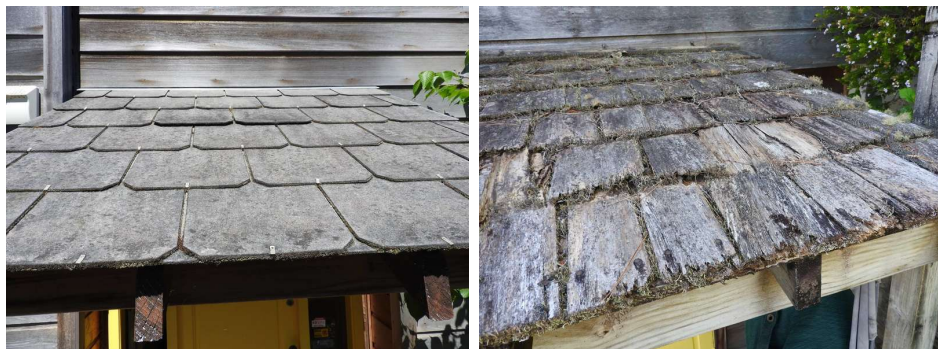
**Eaves, Soffits, Fascia: Eaves/soffit - Inspected**

Material used - Fibre cement product, Material used - Timber

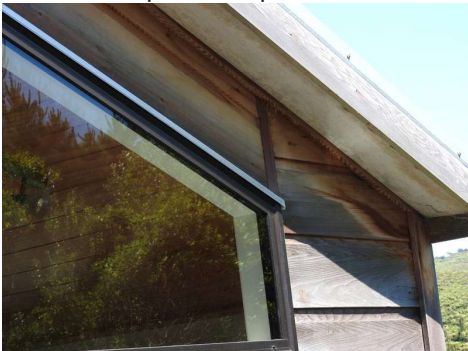
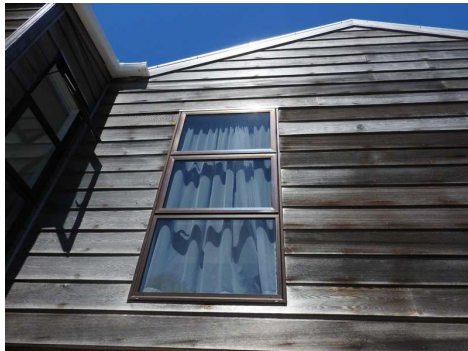
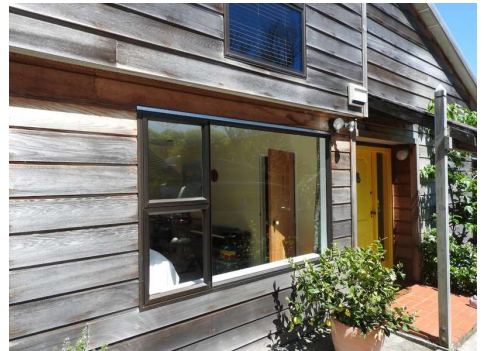
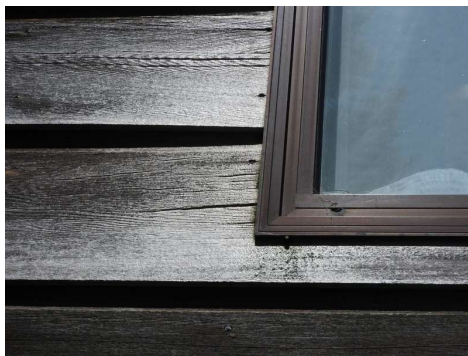
Left undisturbed, asbestos is safe but if it is exposed or damaged, it can be harmful. It poses a risk if it is no longer adequately contained in the material it came in (such as due to damage, being cut or drilled into during building work, home maintenance or wear and tear). For this reason, the Ministry of Health advises homeowners not to undertake home maintenance on materials that may contain asbestos, or dispose of such materials themselves.

Given these rules you can expect any maintenance to these products (if confirmed as asbestos) to be at a significantly higher cost than regular repair costs.

Contact a qualified professional.

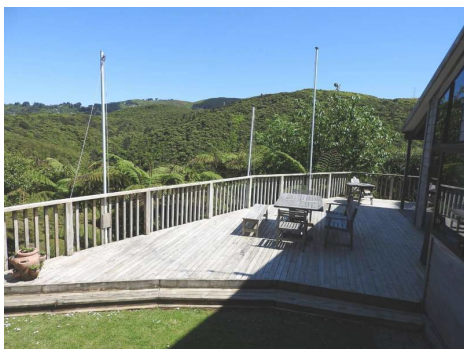
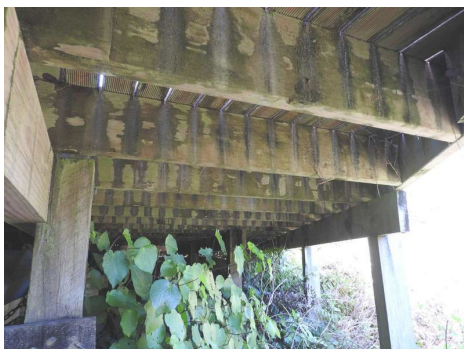
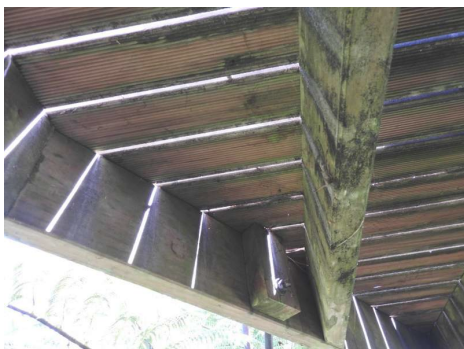
This deck is single bolted with no bracing elements, the balustrade has been fitted in a way that has compromised the post strength and boundary joist connection is just nailed on and some of the timbers are showing sign of aging.

**In short, this would not comply with today's requirements for balustrade and it looks and feels a little tired, consider alteration or replacement to ensure safety from falling.**

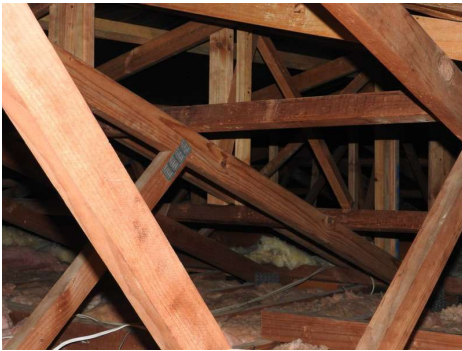
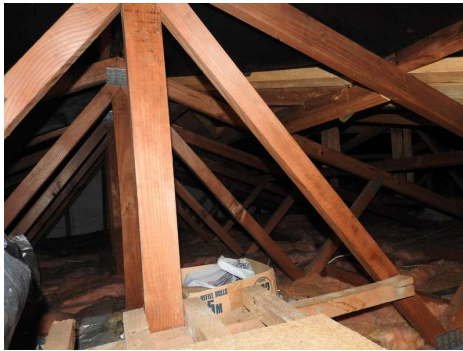
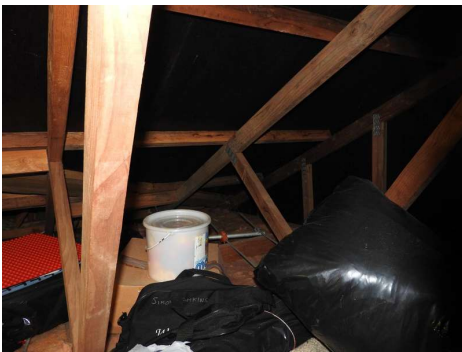
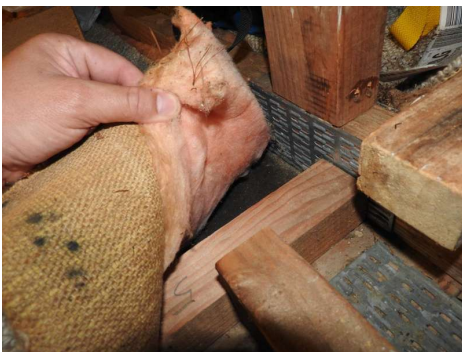
This area looks to be in great condition, there is a tear in the roofing underlay, it doesn't appear to be leaking there.

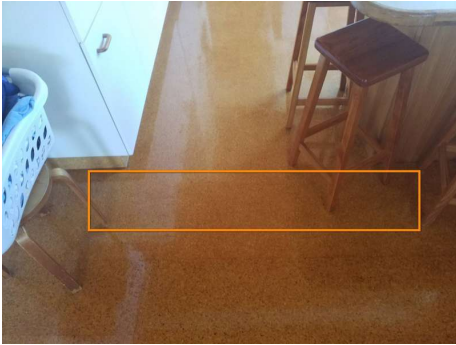
This is the transition between the timber and concrete floor, the area below could not be accessed to inspect a reason for this.

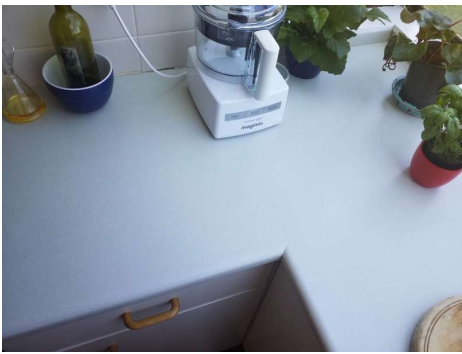
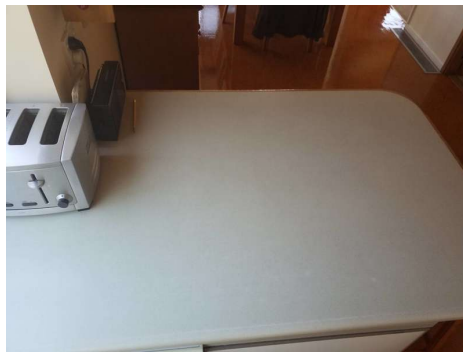
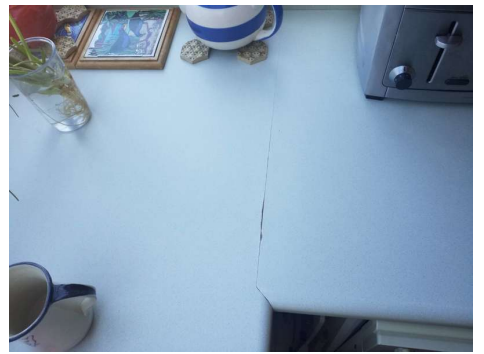
Material - Laminated on composite wood, Damage

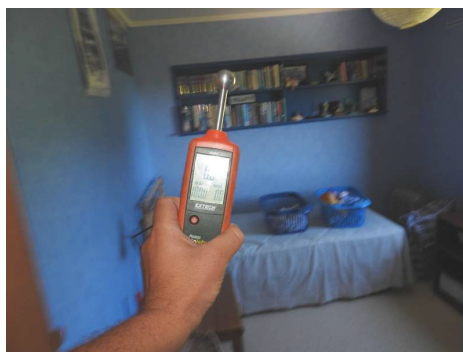
this is reading dry however there is a water stain on the wall here indicating evidence of a leak or condensation issues.

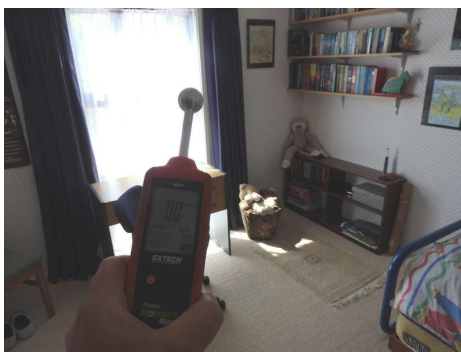
this area is currently reading dry however there is evidence of a leak here.

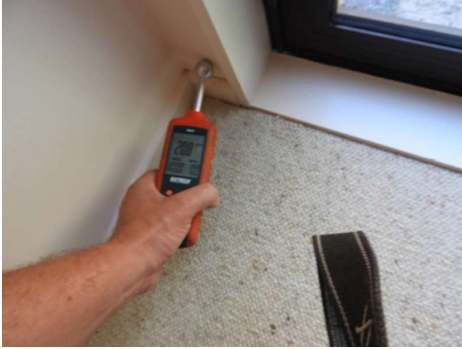
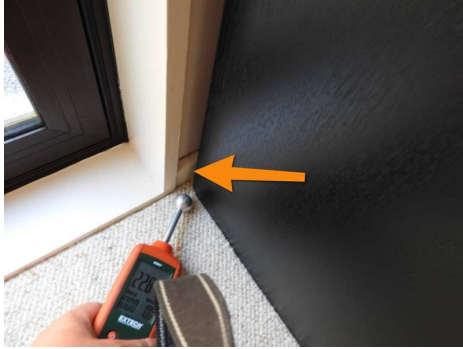
there is evidence of a leak by this door it is reading dry.

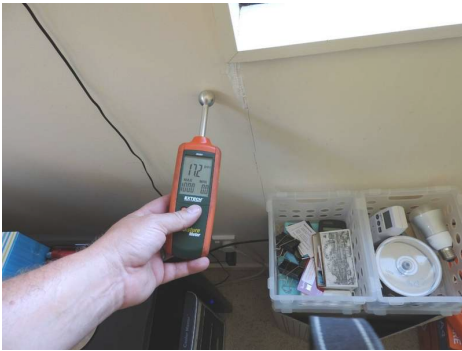
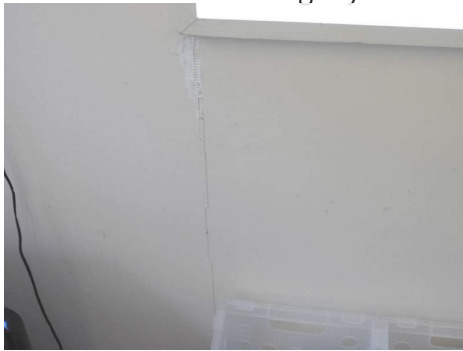
this crack is likely due to bad placement of sheet joints.

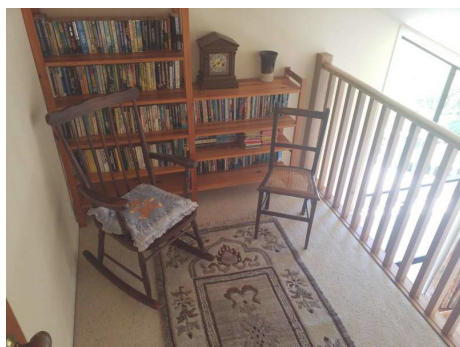
The mini ladder at the entrance here is a little dangerous.

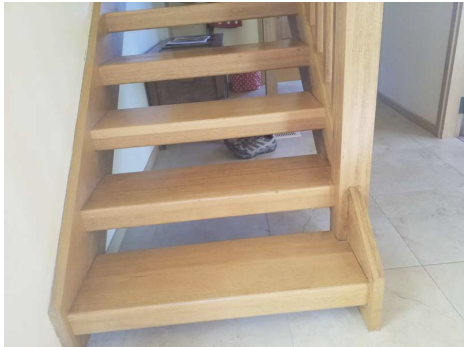
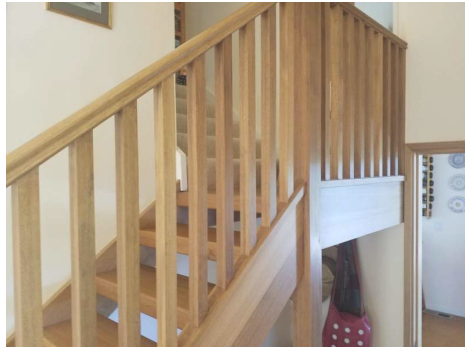
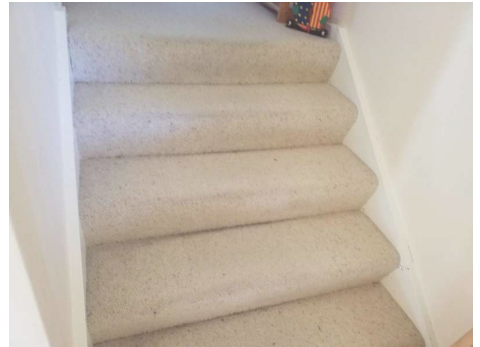
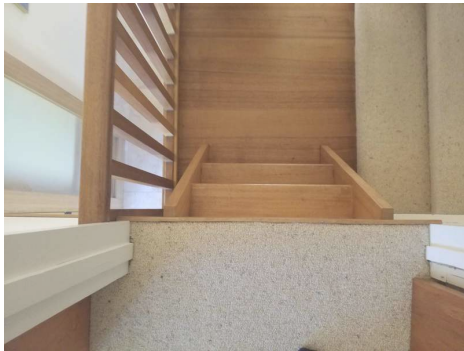
Type - Winding, Material - Timber, Balustrades, Landings

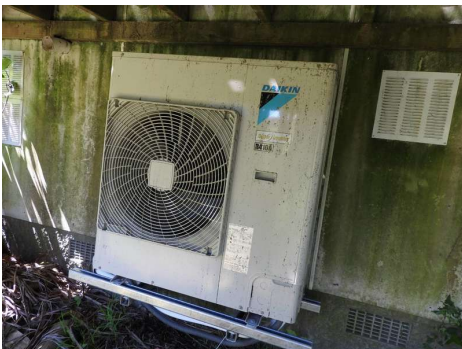
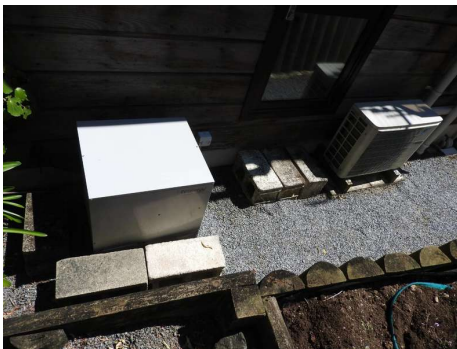
**Inspected presence of : Heating systems**

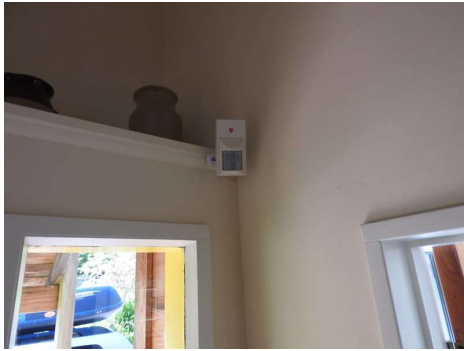
**Inspected presence of : Security system**
