PINPOINT HOME INSPECTIONS

RESIDENTIAL INSPECTION REPORT

1234 Main St.
Knoxville TN 37918

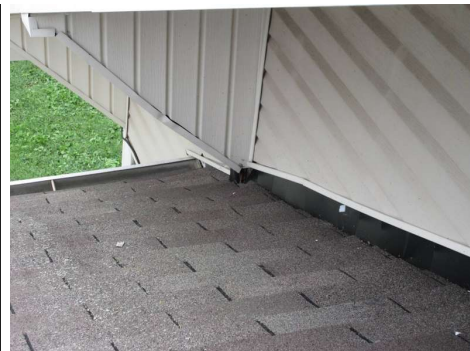
R016

One example of several

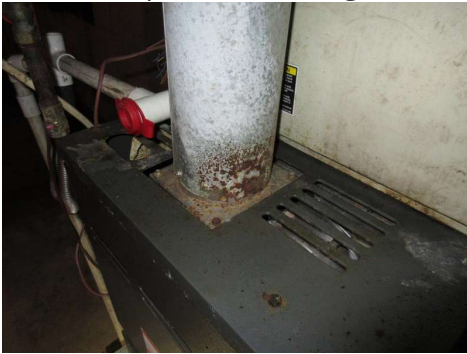
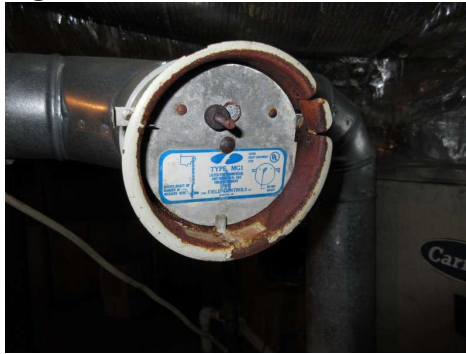
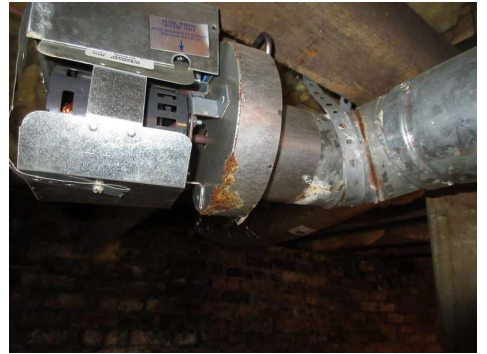
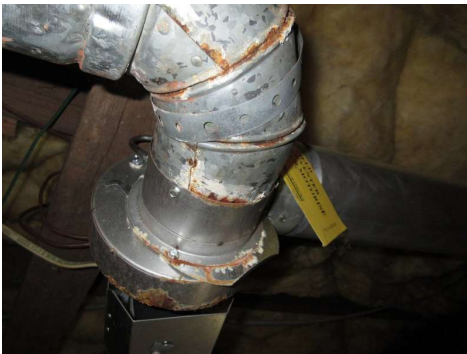
5.2.1 Flue or Vent

FLUE CORROSION

Recommendation

Contact a qualified heating and cooling contractor

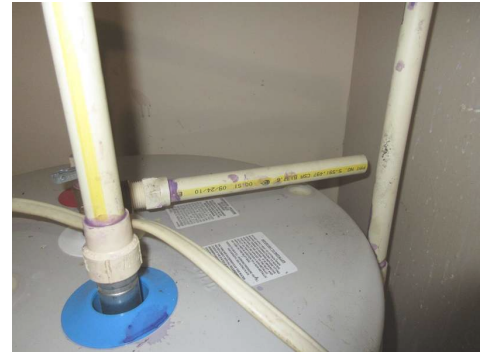
7.1.2 Water Heater

Deficiencies

Recommendation

Contact a qualified professional.

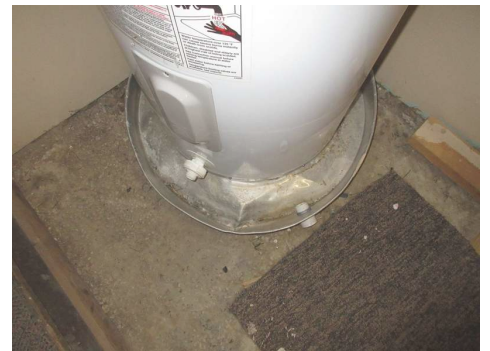
7.1.3 Water Heater

Deficiencies

Recommendation

Contact a qualified professional.

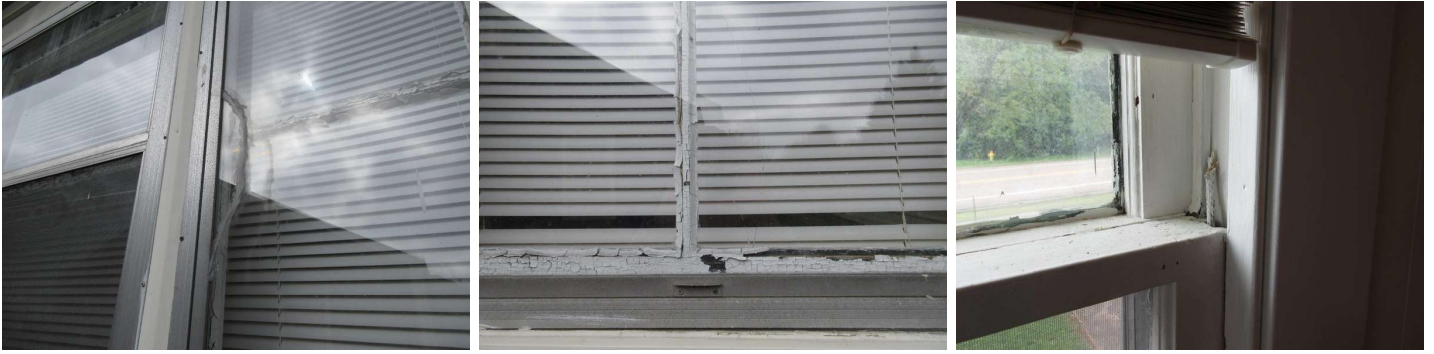
WINDOWS; POOR CONDITION

Contact a qualified professional.

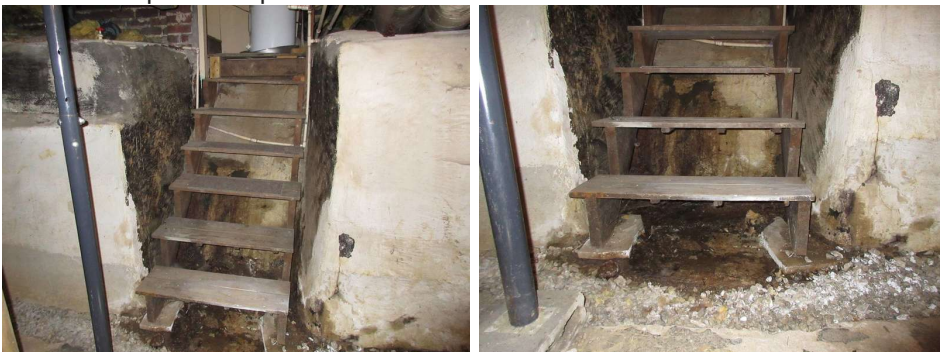
STAIRCASE; OLD UNSTABLE OR DAMAGED

The staircase was old, contained damages which affected its performance, and lacked generally accepted safety measures such as handrails. Recommend a qualified contractor evaluate the staircase and provide options and costs for repair or replacement.

Contact a qualified professional.

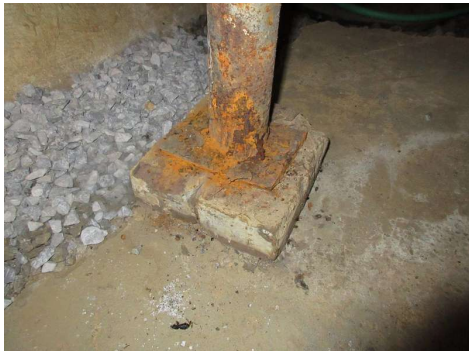
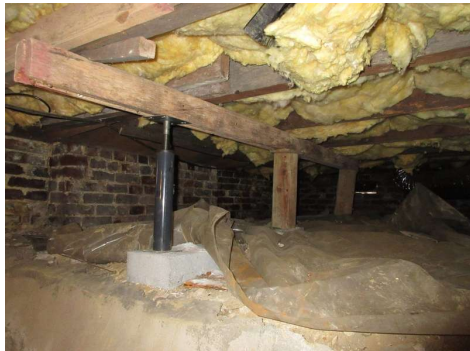
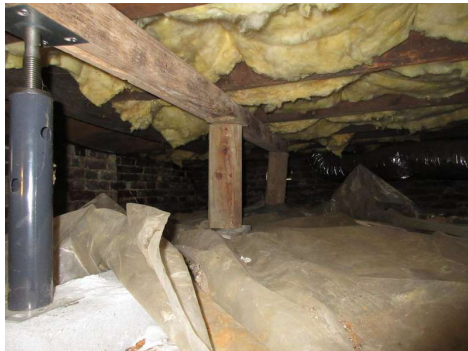
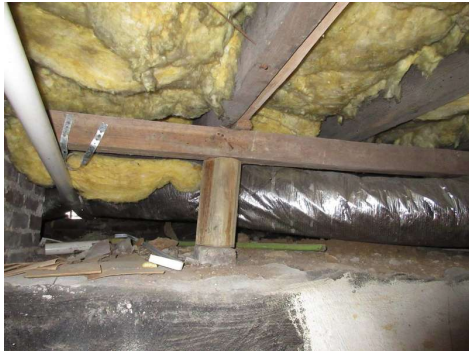
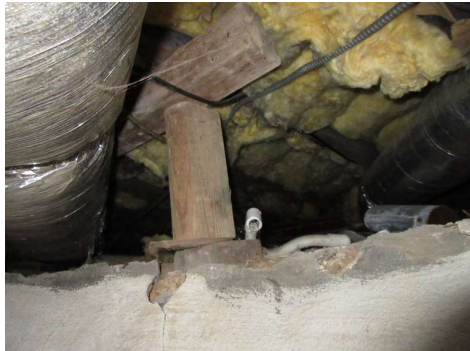
FLOOR SUPPORT; DEFICIENCIES

Contact a qualified structural engineer.

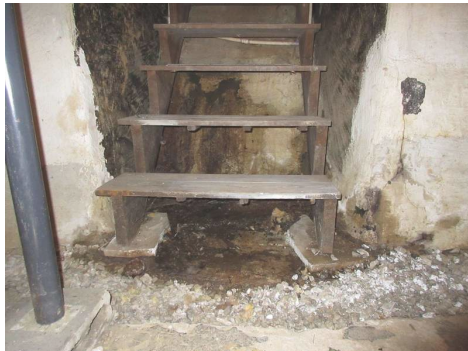
11.6.2 Crawlspace & Basements

VAPOR BARRIER; MISSING OR GAPS
