## TREC RESIDENTIAL

1234 Main St.  
Melissa TX 75454

# PROPERTY INSPECTION REPORT

**By:** Chris Scanland - Professional Inspector TREC# 23176      04/19/2019 9:00AM  
(Name and License Number of Inspector)      (Date)

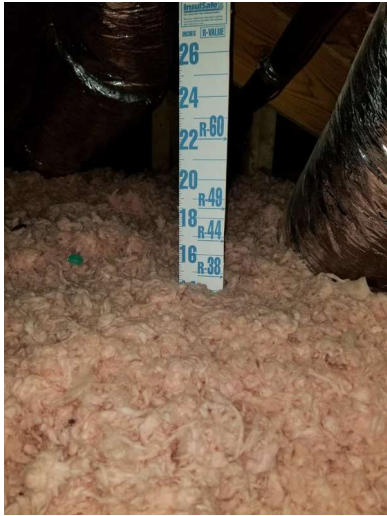
*Approximate Average Depth of Insulation: 15 Inches*

Recommended Insulation Depth
