# CAL-PRO REAL ESTATE INSPECTIONS

## PROPERTY INSPECTION REPORT

1234 Main St.  
Bakersfield California 93306

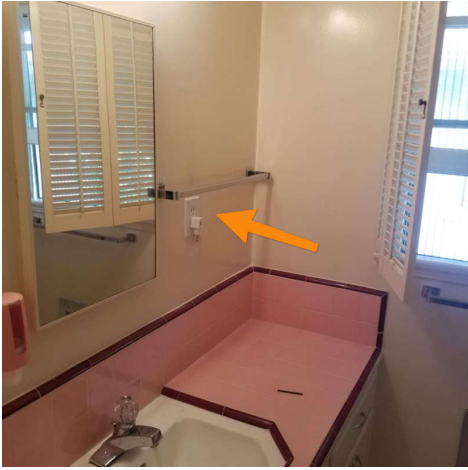
Hallway Bath

### **REVERSE POLARITY**

Contact a qualified electrical contractor.
