RED CARPET HOME INSPECTIONS

RED CARPET HOME INSPECTIONS - SFH/TH/DUPLEX

1234 Main St.
Haymarket VA 20169

Buyer Name
02/24/2019 9:00AM

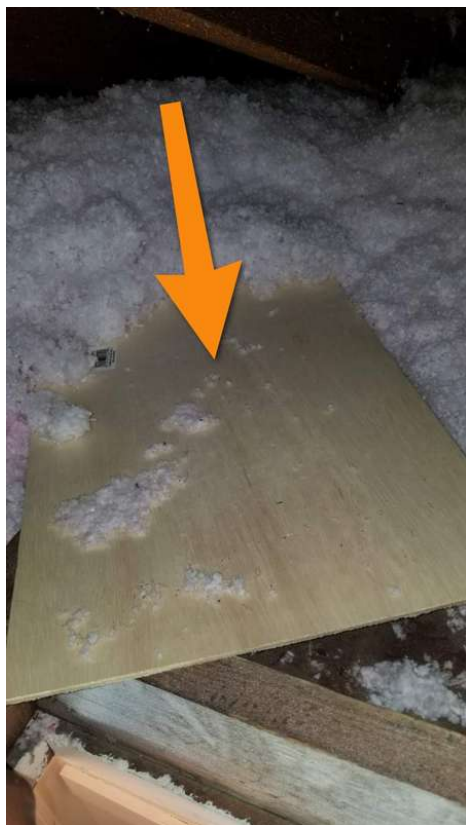
Lack of insulation around attic access door causes energy loss

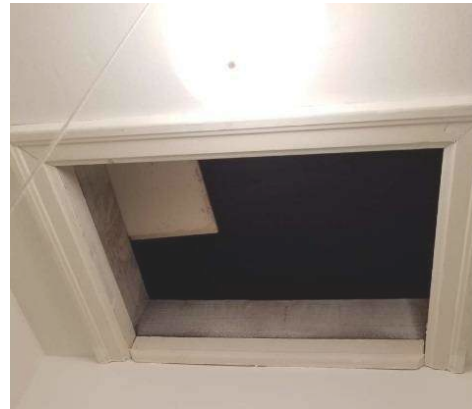
3.3.1 Roof Structures

RAFTERS BROKEN, CUT OR NOTCHED OUT

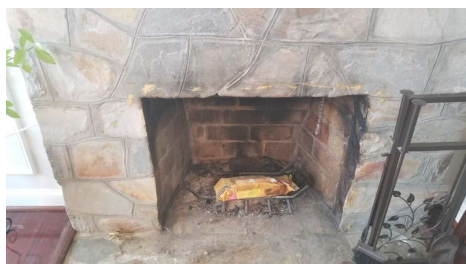
Wood burning fireplace with a stone front

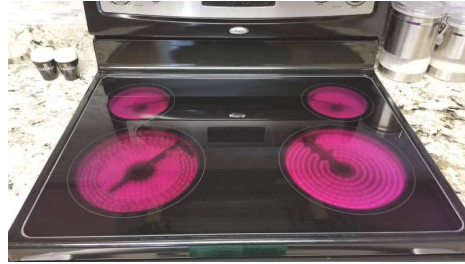
Whirlpool Range with burners fully functional

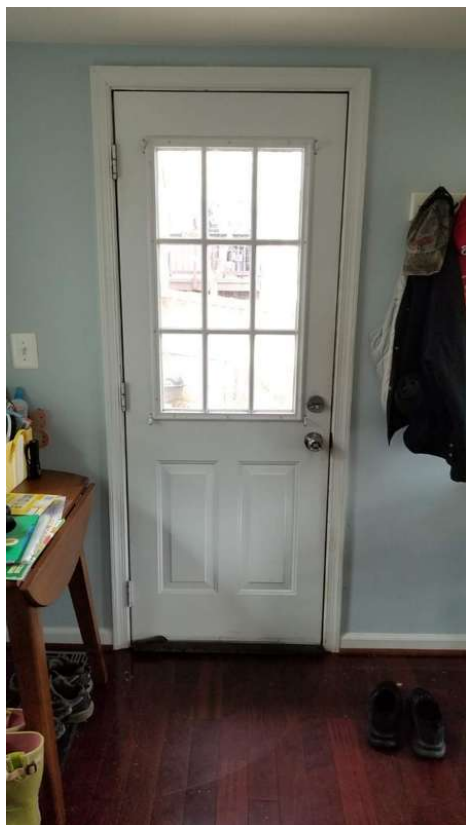
Door leading to the exterior of the house

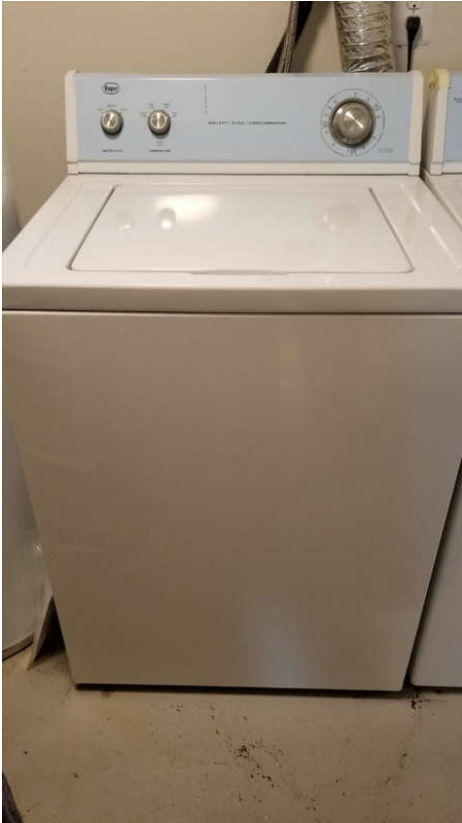
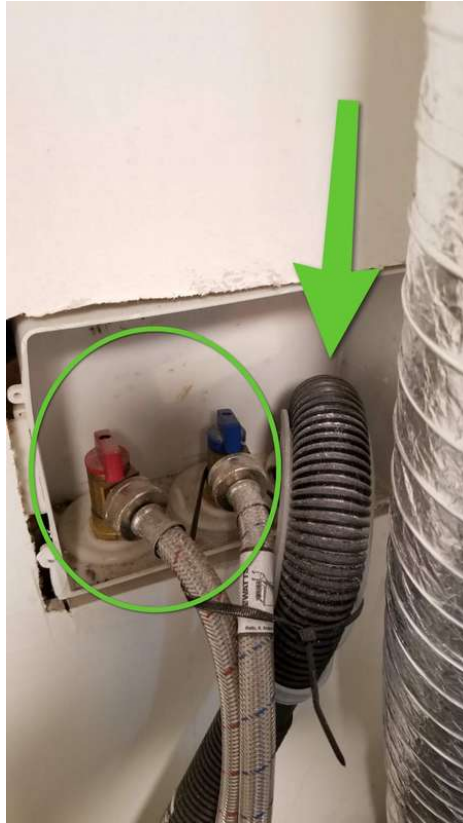
Green circle = water shutoffs
Green arrow = water discharge drain pipe

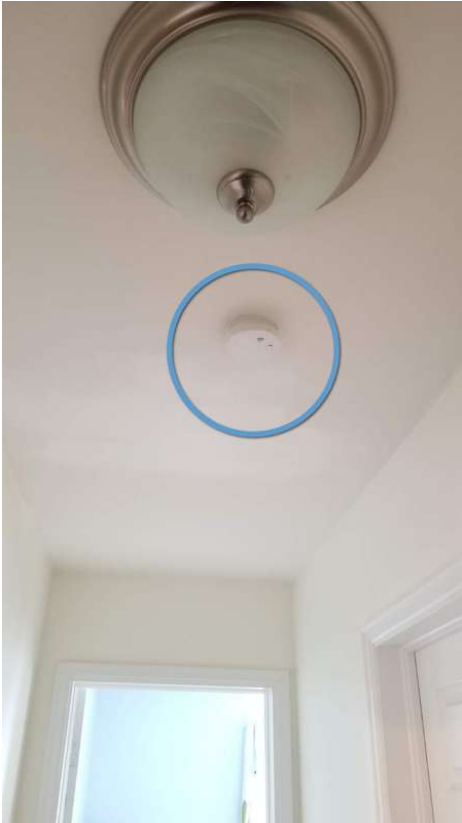
Upstairs hallway

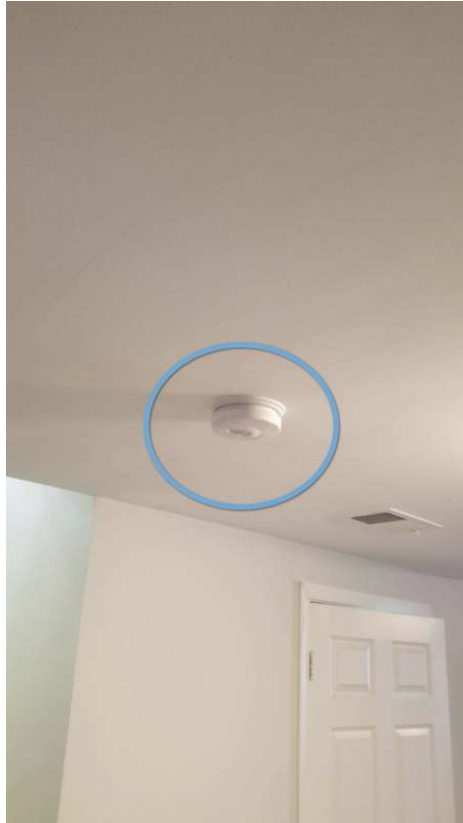
Basement living room

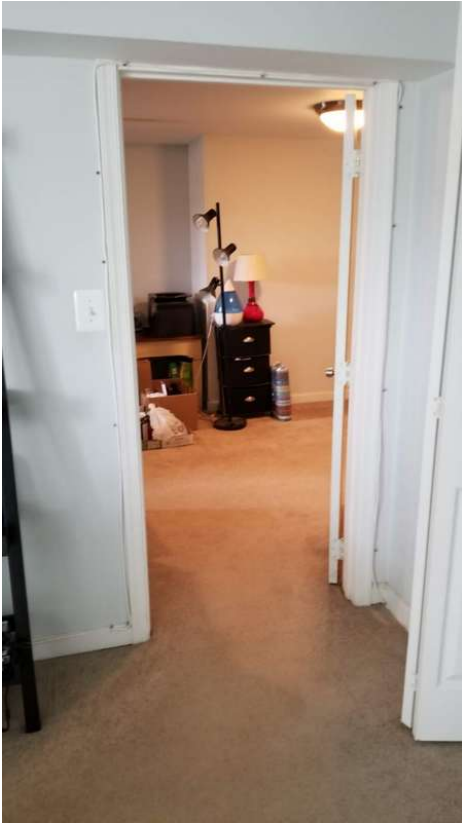
Master bedroom in the basement
Entry Door

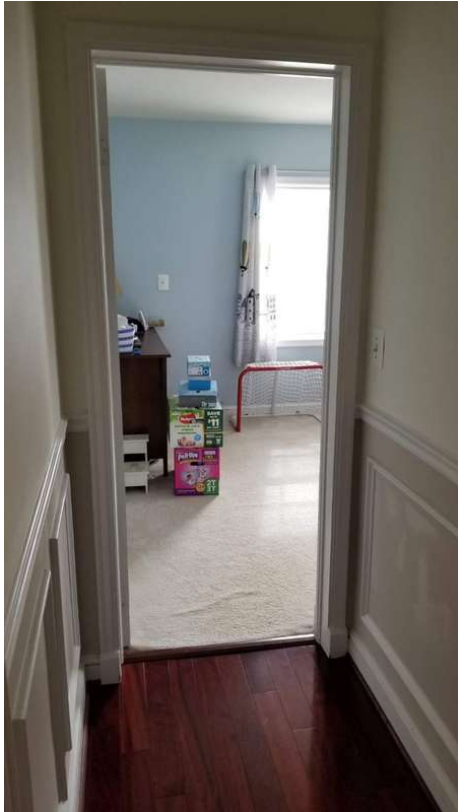
Upstairs westside of the hallway
