SUMMARY

1234 Main St. Oreana IL 62554

Buyer Name
06/28/2018 9:00AM

Michael Bell
License #450.011879
Titan Home Inspections
217-329-4126

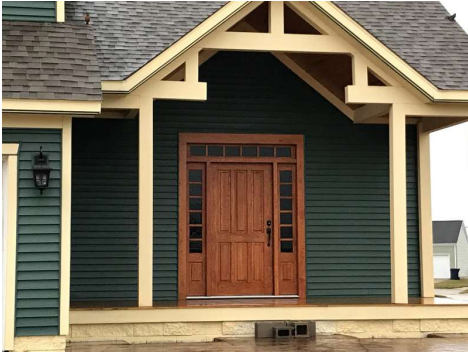
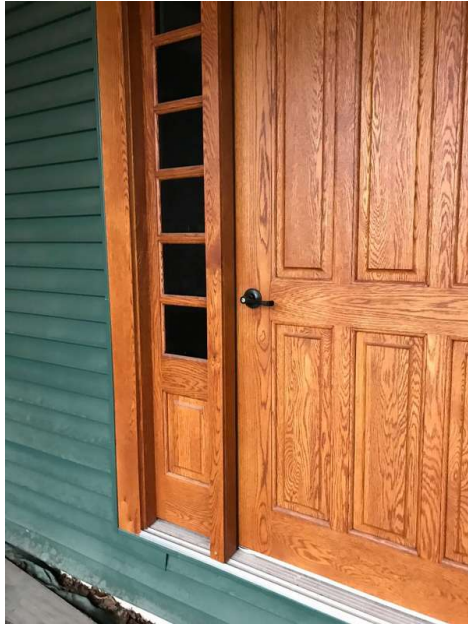
OTHER DOORS

I observed no indications of deficiencies in the Front or Rear entry doors during the time of inspection.

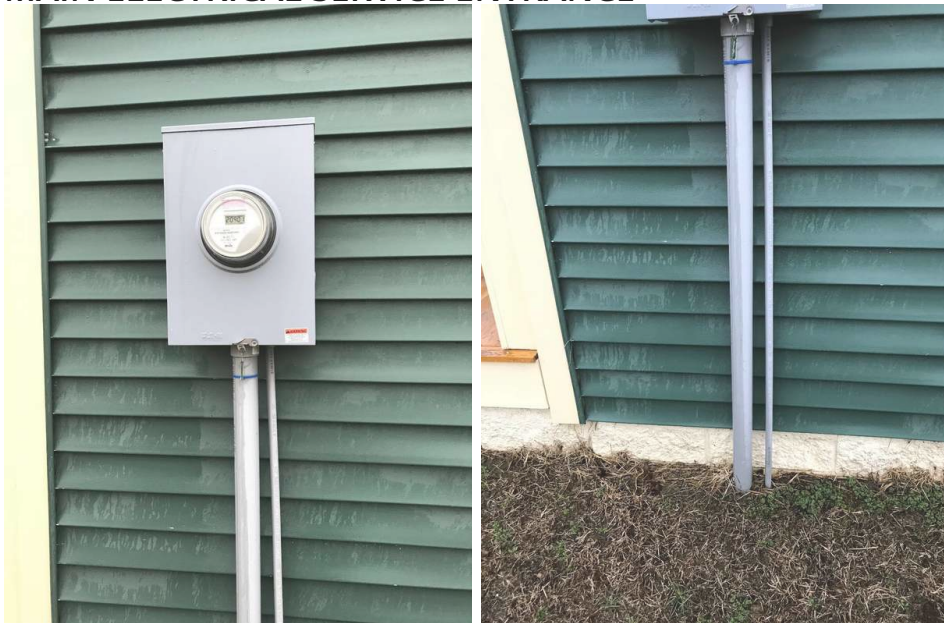
8.1.1 Service Entrance Conductors

MAIN ELECTRICAL SERVICE ENTRANCE

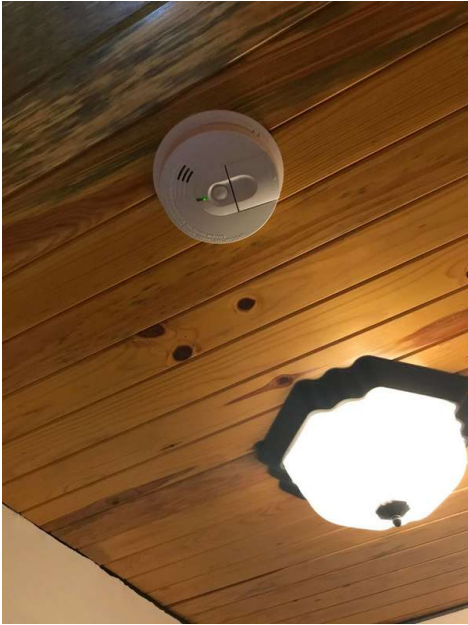
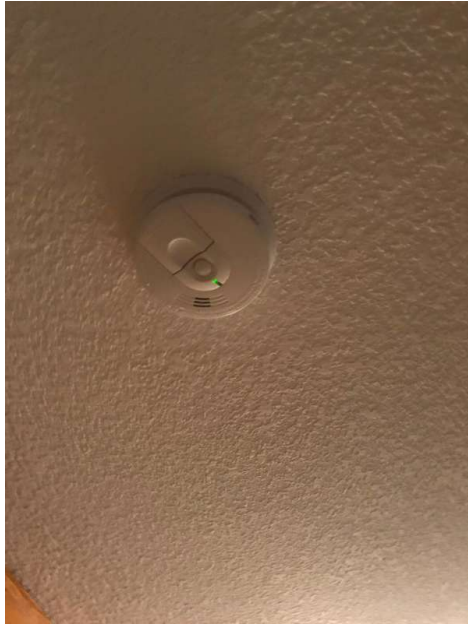
8.6.1 Smoke Detectors

SMOKE DETECTORS INSTALLED

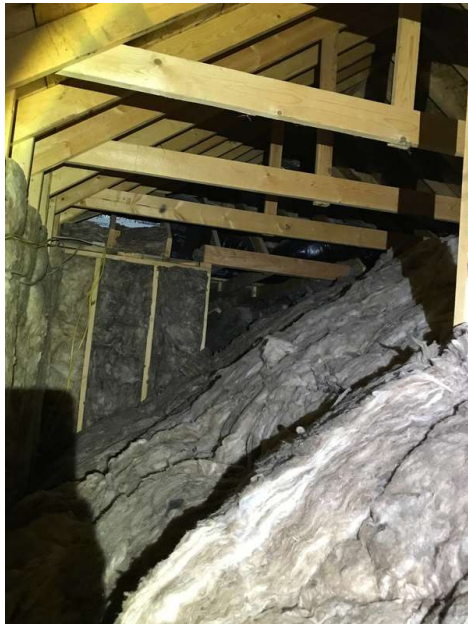
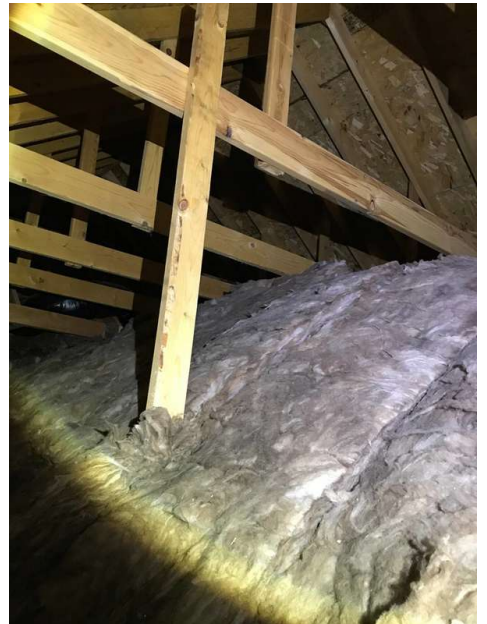
9.1.1 Attic Insulation

ATTIC INSULATION OBSERVED

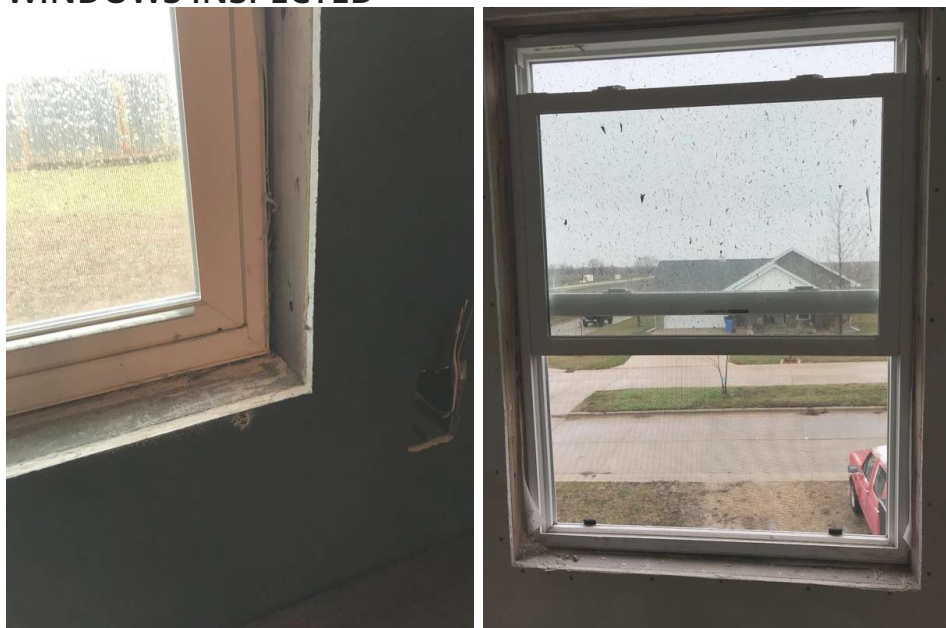
10.2.1 Windows

WINDOWS INSPECTED
