2.1.1 Siding, Flashing & Trim

DAMAGED SIDING

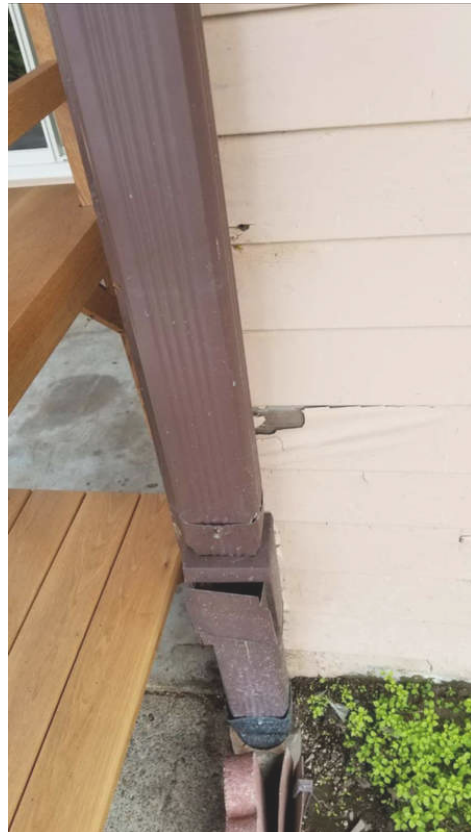
Rear

Siding appears to be damaged numerous locations budget for repairs. I recommend evaluation and repair as needed.

Recommendation
Contact a qualified siding specialist.

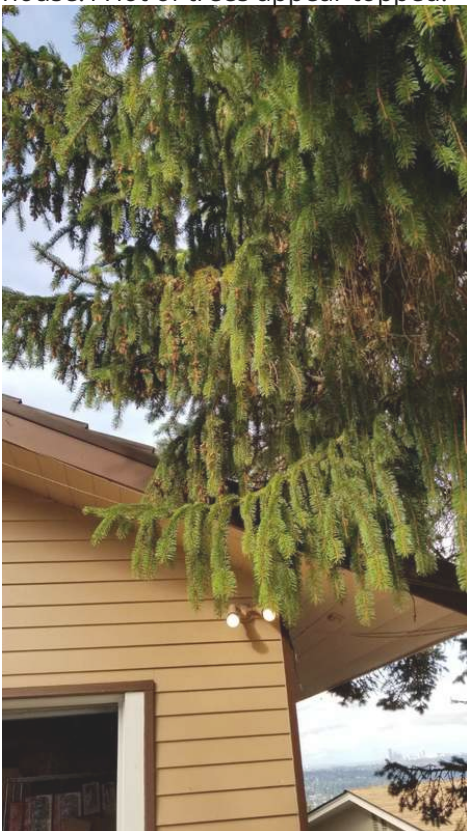
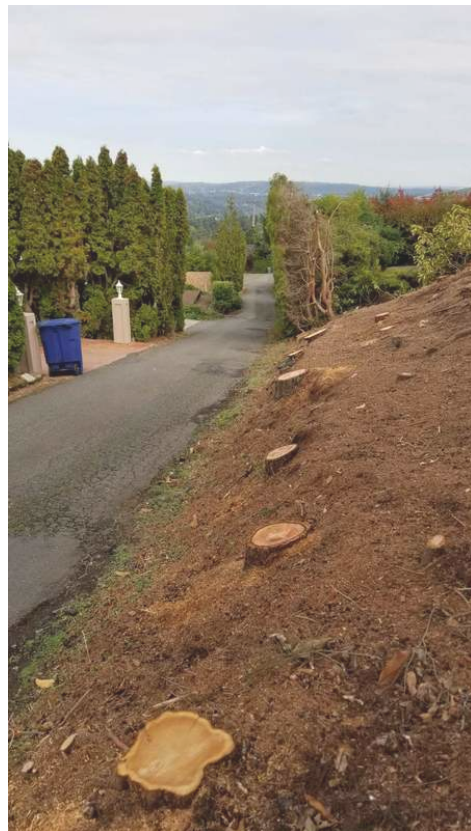
Appears to be a dead tree front of house. A lot of trees appear topped.

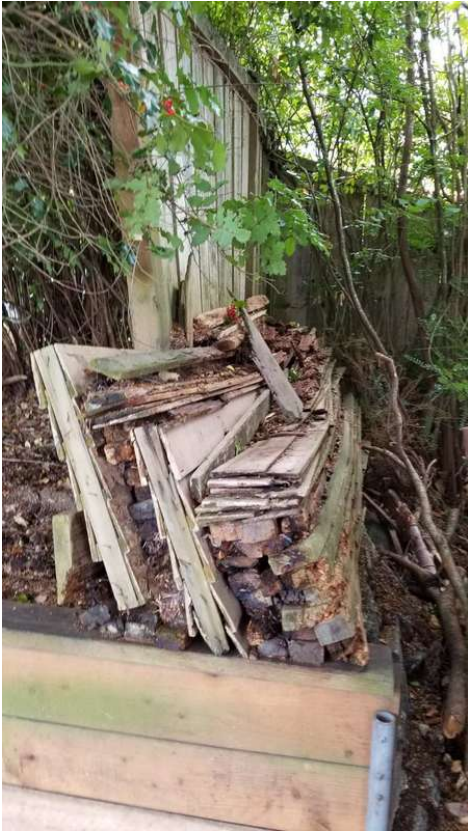
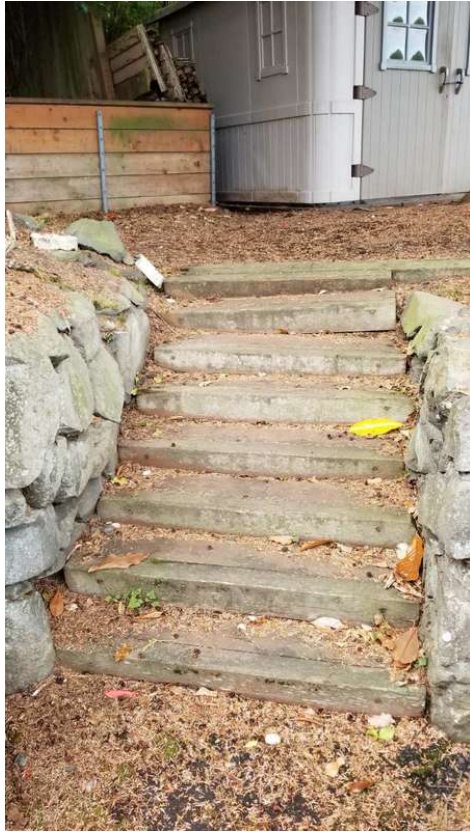
RETAINING WALL CRACKS

Retaining wall is showing signs of failing. Recommend qualified contractor evaluate and repair.

Contact a qualified landscaping contractor

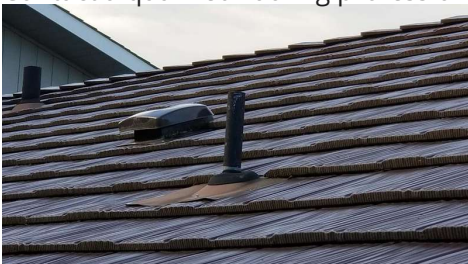
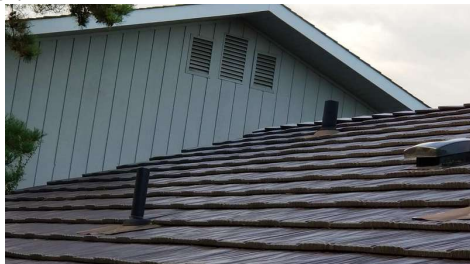
IMPROPER FLASHING SYSTEM

Contact a qualified roofing professional.

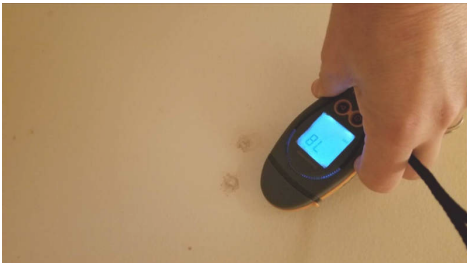
Master bathroom

Residue appears fungal in nature on ceiling. I did not inspect, test or determine if this growth is or is not a health hazard. This type of testing is beyond the scope of a standard home inspection. The underlying cause is moisture or dampness. No obvious elevated moisture at time of inspection. Fungus noted numerous locations. Dry at time of inspection.

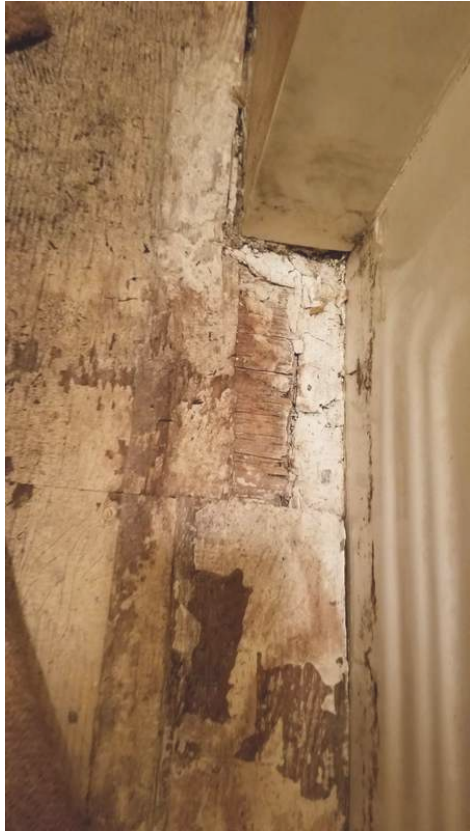
Rotting floor master

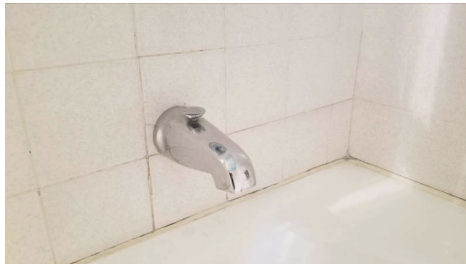
Guest bath tile movement

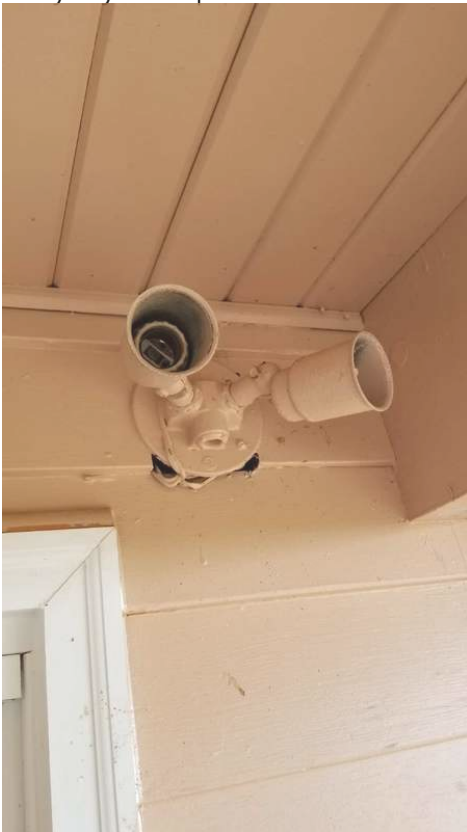
Unknown in solarium

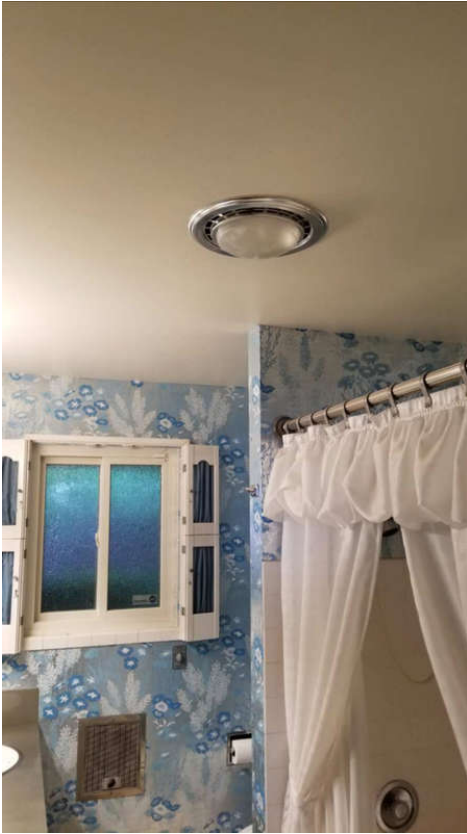
Non-operable guest bathroom
