**SUMMARY**  
1234 Main St. Merrimack NH 03054  
Buyer Name  
01/21/2019 9:00AM

Chris Caisse  
InterNACHI Certified...  
Platinum Home Inspections  
603.897.5495

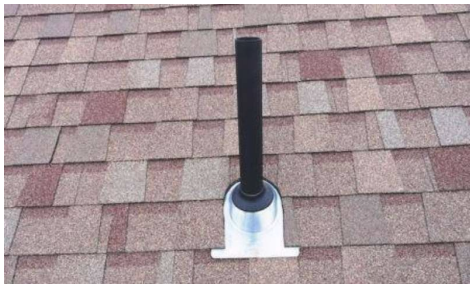
2.3.2 Flashings

**DWV PIPE FLASHING - MISSING COVER SHINGLE ON RIGHT SIDE**

Drain, waste and vent pipe flashing should be covered on the back and sides by the shingles. Bottom edge/apron of the flashing should be the only exposed area. Recommend qualified roofing contractor rectify to prevent potential moisture intrusion.

Contact a qualified professional.

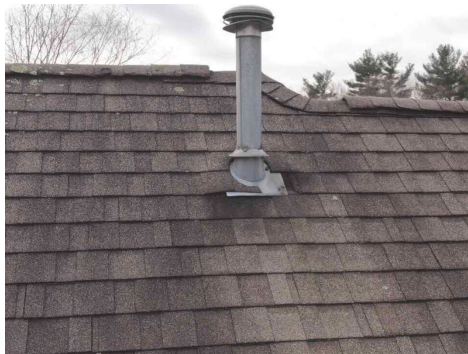
Example of properly flashed DWV Pipe.

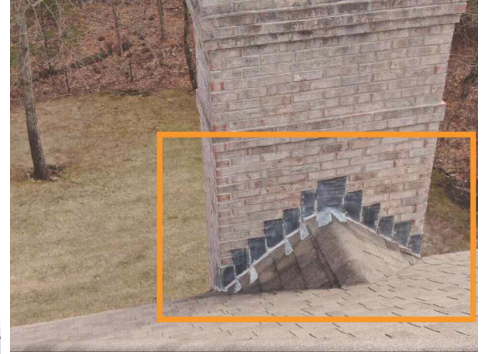
Example #2 of properly flashed cricket.

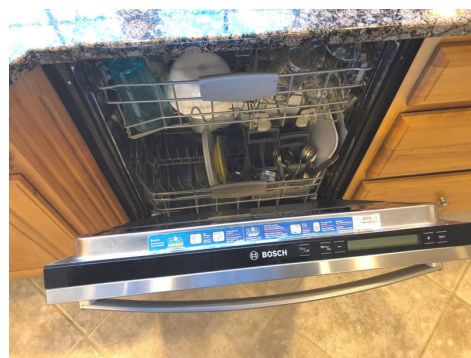
15.3.2 Dishwasher  
**HIGH LOOP NOT PRESENT**

The high loop is designed to prevent wastewater from contaminating the dishwasher. The drain for this DW runs straight along the bottom of the base cabinet then up into drain.
