RESIDENTIAL INSPECTION

1234 Main Street
Denver CO 80210

02/15/2025 9:00AM

PROPERTY INSPECTION REPORT FORM

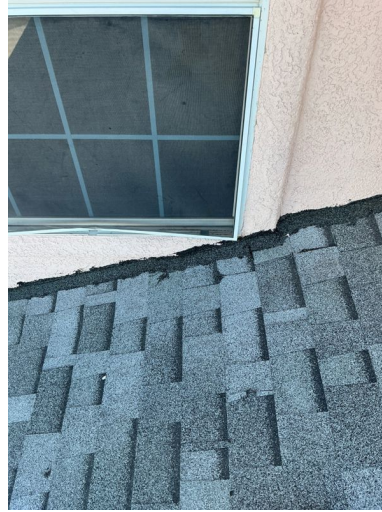
5: Skylight Leakage

The skylight shows signs of previous leakage. This should be closely monitored and corrected if necessary.

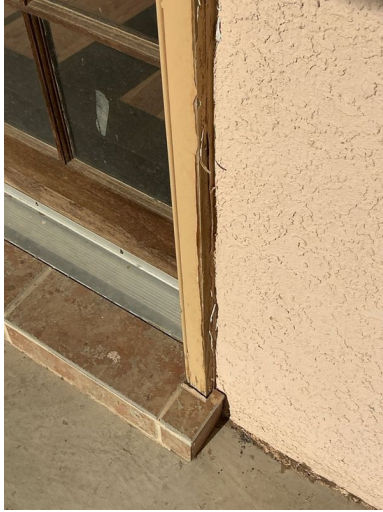
7: Wood Trim Damaged

The wood veneer trim has some deterioration or damage.

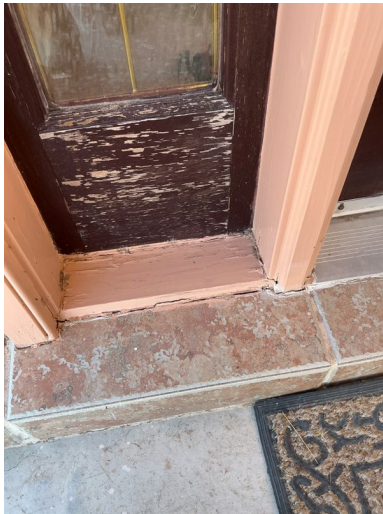
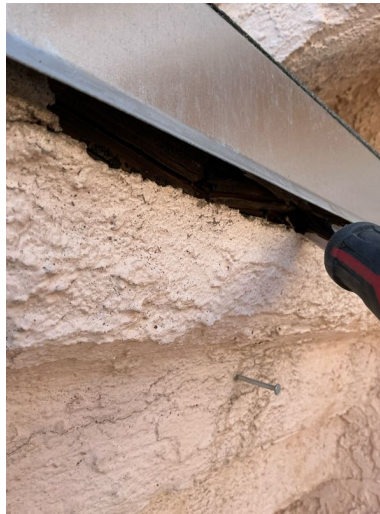
8: Stucco - Ground Clearance

The exterior stucco type veneer/cladding has inadequate clearance from the finished grade (ground). Most manufacturers require a minimum of 4- to 6-inches of clearance from the finished grade (ground). This was a common installation for the age and area of the house, however does not meet industry standards. It is recommended that this area be closely monitored for water damage, and grading improvements are made to ensure water or moist dirt does not make prolonged contact with the stucco.

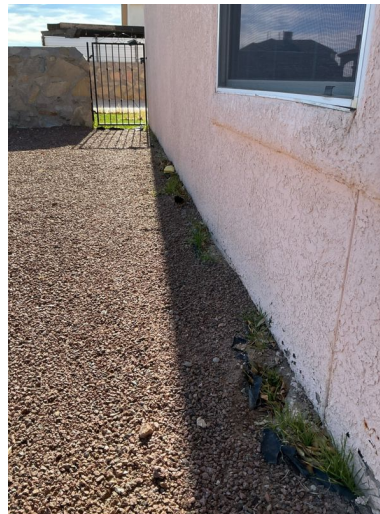
9: Stucco - Flatwork Clearance

The exterior stucco type veneer/cladding has inadequate clearance from the concrete flatwork. Most manufacturers require a minimum of 2-inches of clearance from all concrete flatwork.

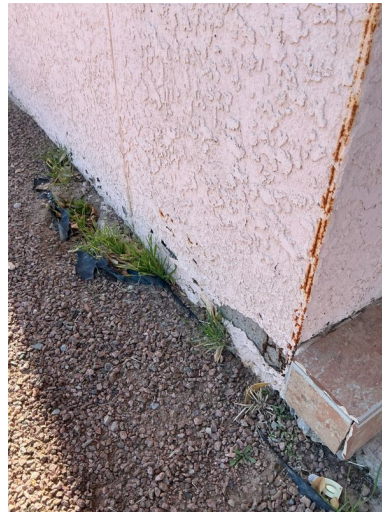
12: Stucco - Cracks

Cracking of the stucco type veneer/cladding was observed. This condition should be further evaluated and corrected as necessary.

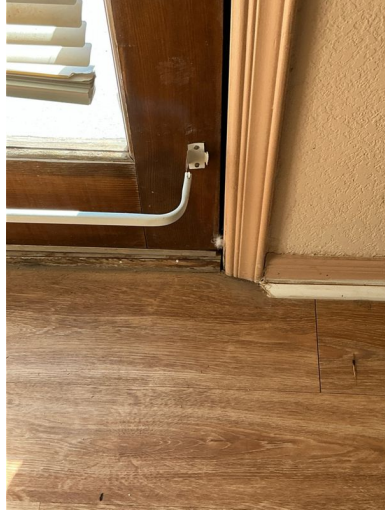
2: Door - Hardware Missing

Door stops missing in multiple locations.

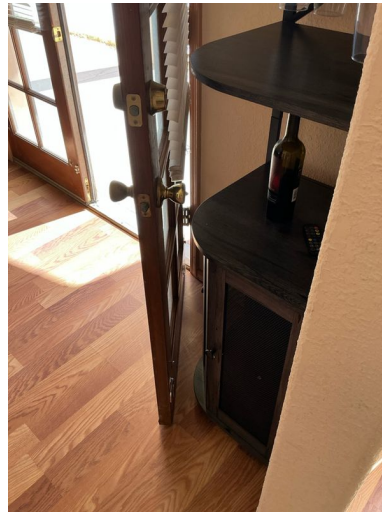
3: Door - Hardware not Functioning

Back door, pantry

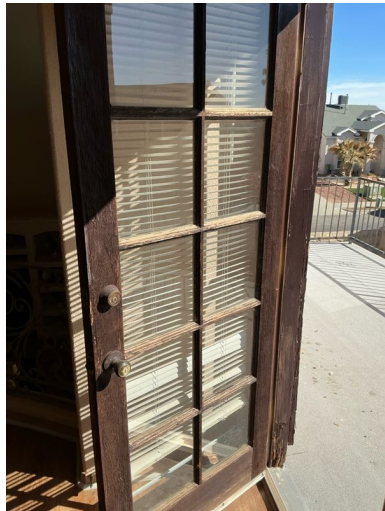
7: Door - Weather-stripping Improvements

Balcony

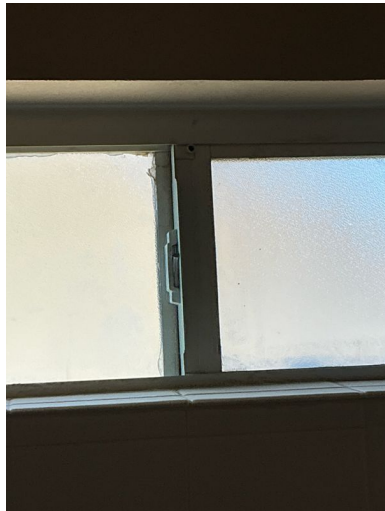
3: Damaged Guides

Several areas

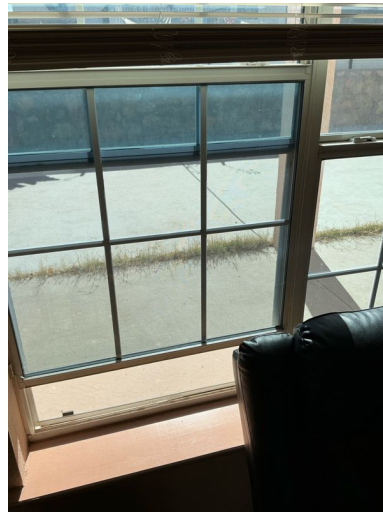
4: Difficult to Operate

One or more of the windows were observed to be stiff and hard to operate.

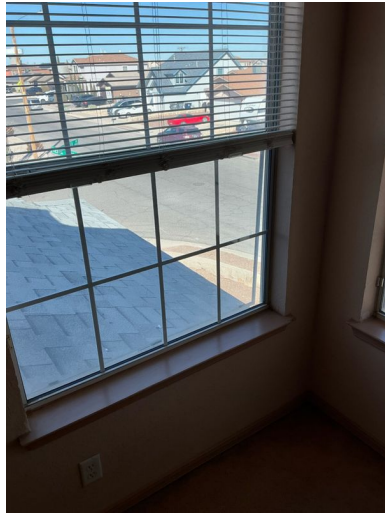
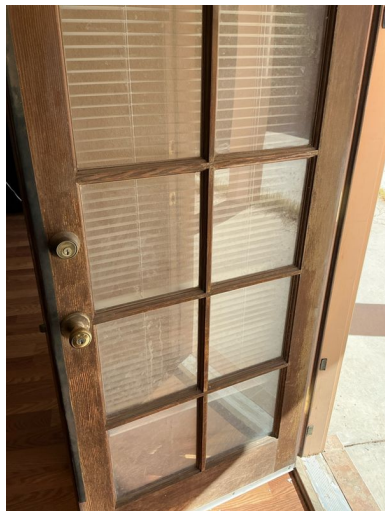
5: Safety Glass - Near or In Door

Several exterior doors

Lack of safety glass near and/or in door. Under current building standards, this is hazardous.

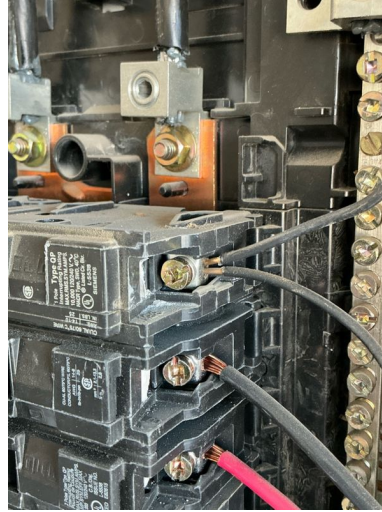
One or more of the breakers in the electrical cabinet were observed to be double lugged (i.e. two wires under one screw). The breakers in place are not listed or labeled for this type of installation and should be corrected as necessary.

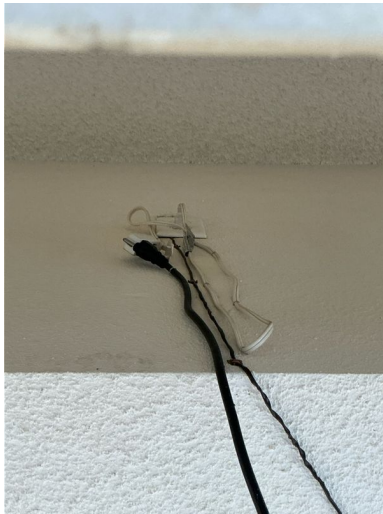
3: Improper use of Extension Cord

Electrical flex extension cords should not be used for permanent wiring or pass through walls or ceilings.

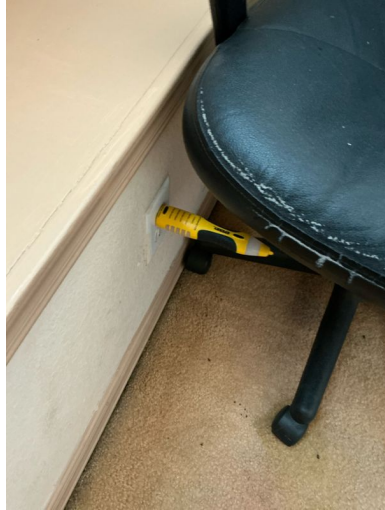
6: Reversed Polarity

Laundry

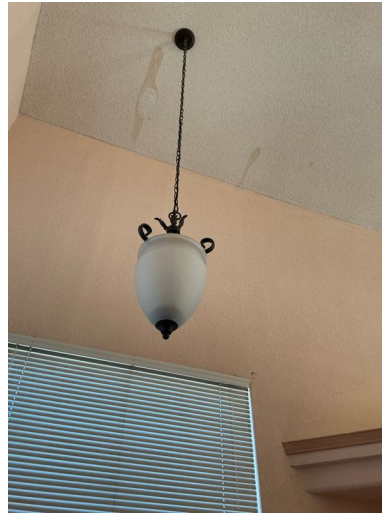
8: Missing Globe

One or more of the light fixture globes and/or covers are missing.

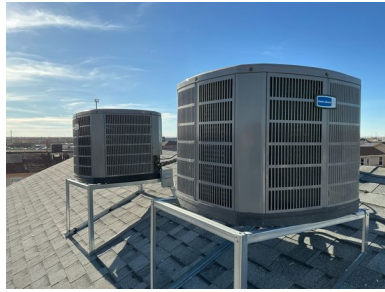
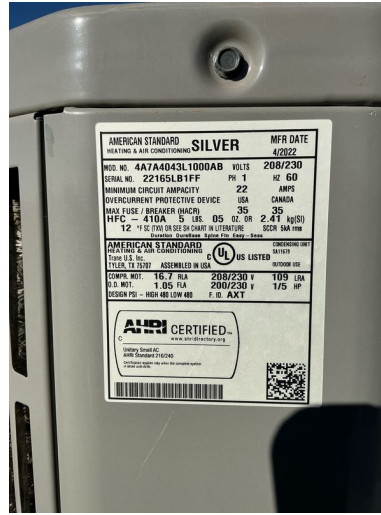
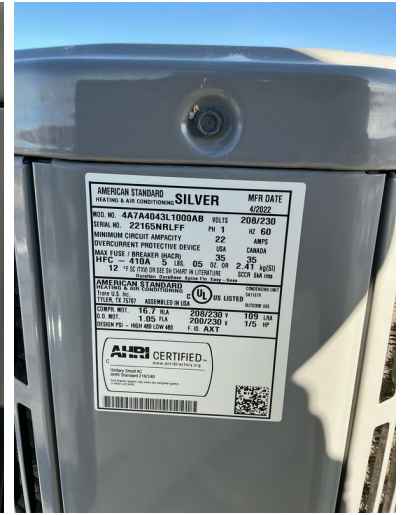
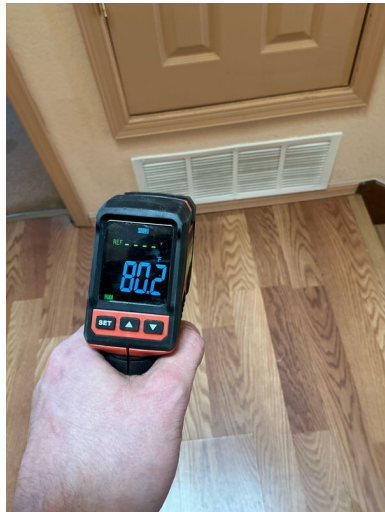
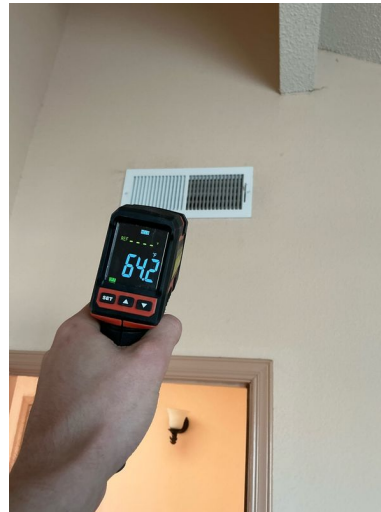
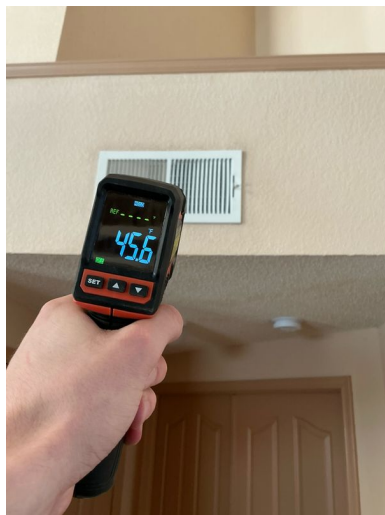
Temperature Differential: 16°, 22°

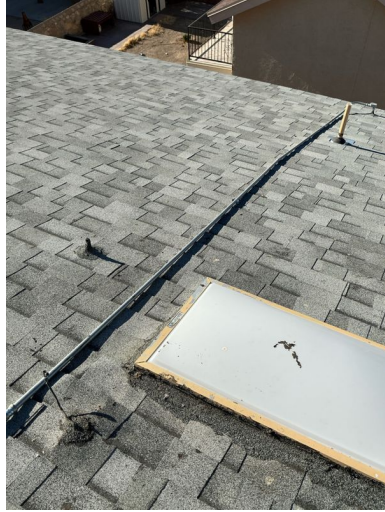
The electrical conduit is not supported.

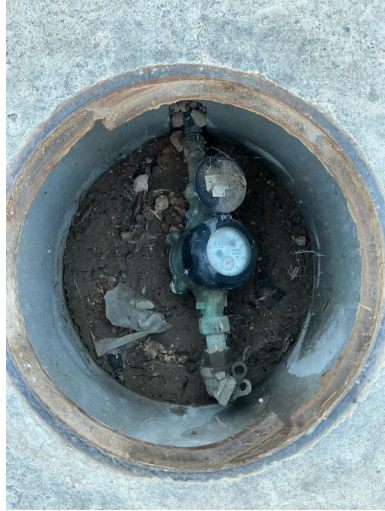
Location of Water Meter: Curb

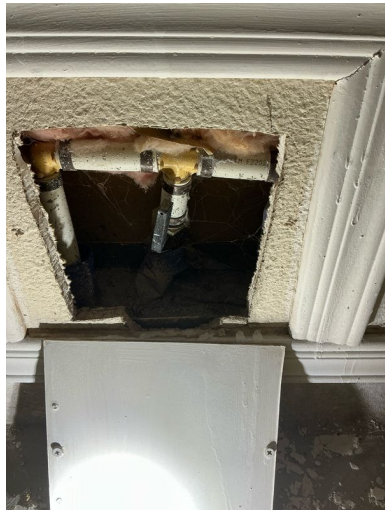
Location of Main Water Supply Valve : Meter, Garage

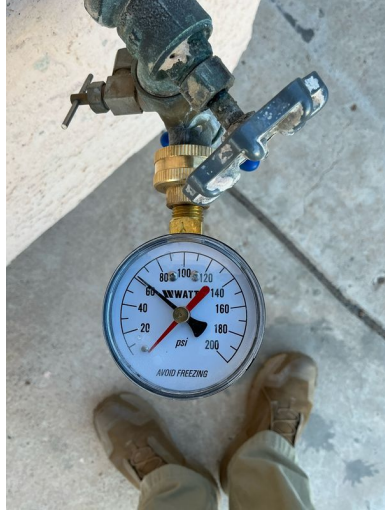
Static Water Pressure Reading: 60 to 65 psi

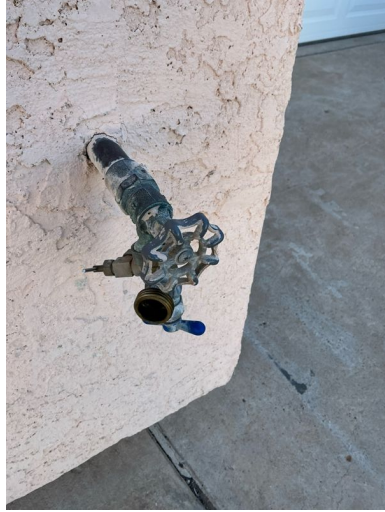
One or more of the exterior water hose bibbs (faucet) do not have a back-flow or anti-siphon device (Vacuum Breakers) in place. Note: This is not uncommon to observe with a home of this age.

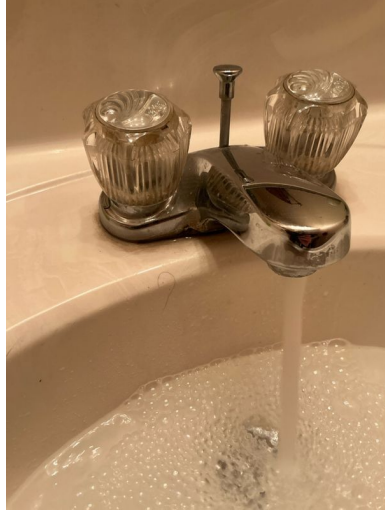
5: Sink - Leaks at base

The faucet leaks at the base when operated.

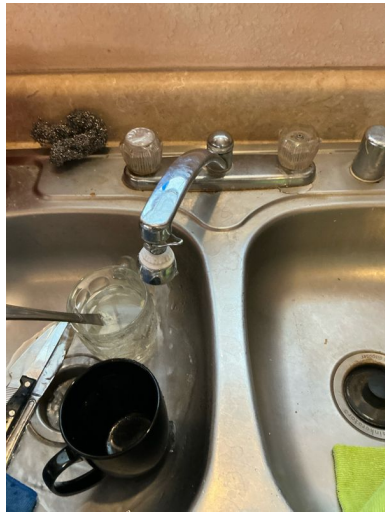
6: Sink - Noisy Operation

The faucet is unusually noisy (humming) at the time of inspection. This condition should be further evaluated and corrected if necessary.

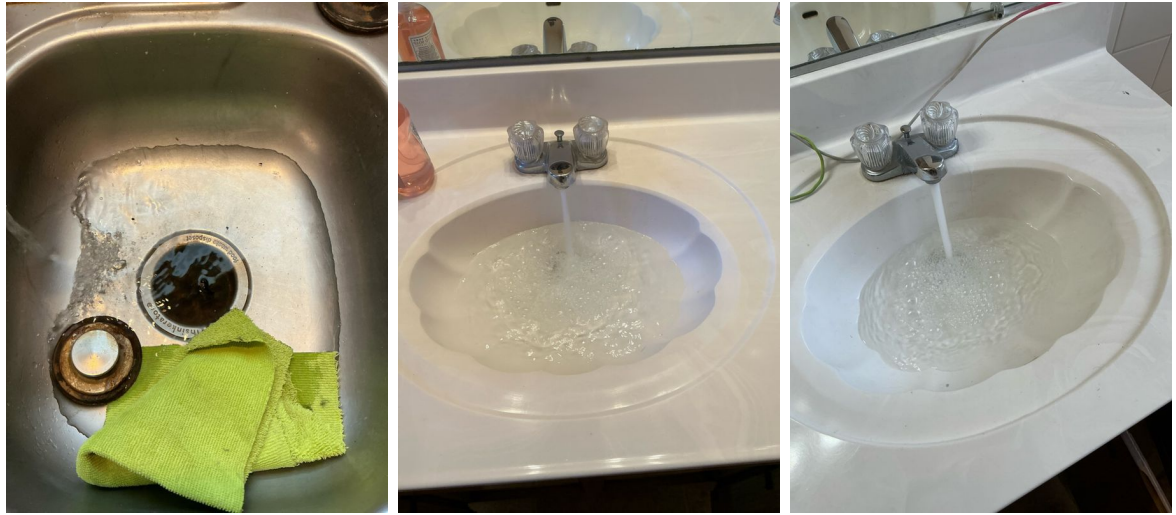
7: Sink - Slow Drain

The sink was observed to drain slowly, suggesting that an obstruction may exist.

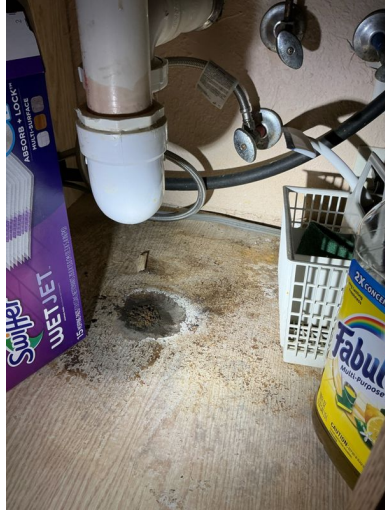
9: Sink - Drain Leaks

The drain leaks water into when drained under pressure with a large volume of water.

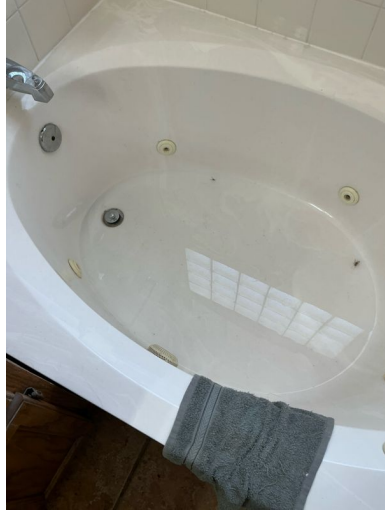
The bathtub was observed to drain slowly, suggesting that an obstruction may exist.

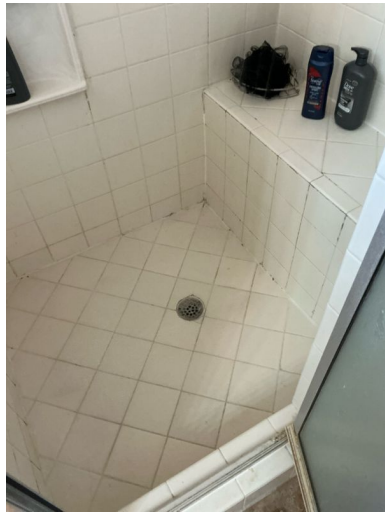
12: Shower - Grout/Caulking Improvements

Cracked, deteriorated and/or missing shower stall grout and/or caulking should be repaired or replaced as necessary

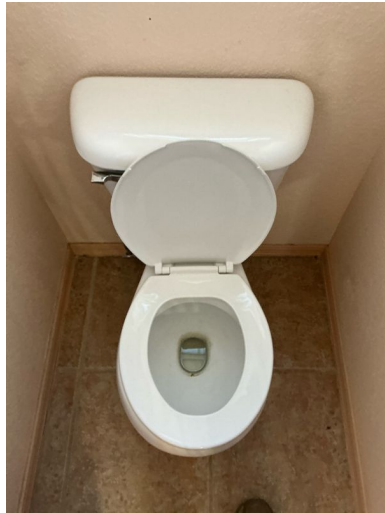
13: Toilet - Inoperative

The commode is inoperative. The cause and remedy should be further evaluated and corrected as necessary.

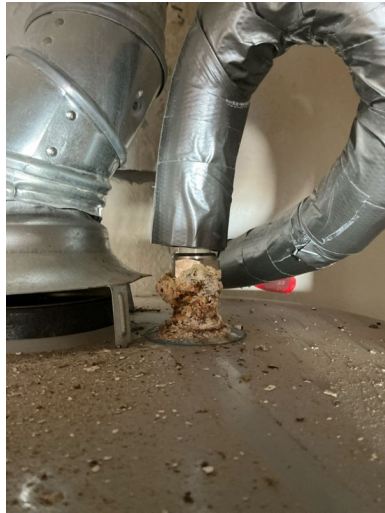
1: Corrosion Connections

Some corrosion was observed at the water supply connections at the top of the water heater.

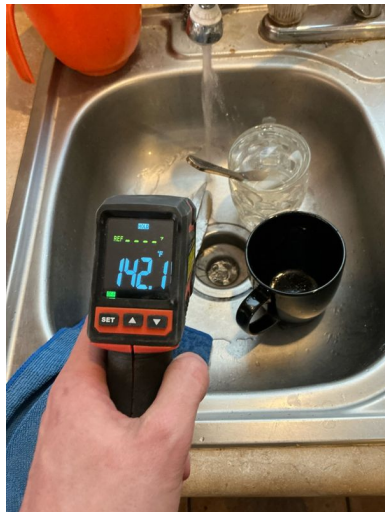
2: Water Temperature Too High

Note: The water temperature was observed to be over 140 degrees Fahrenheit when running the hot water. This high temperature could cause scalding/burning of the skin. It is recommended to adjust the temperature on the water heater to a lower setting. The general recommended setting for a water heater is between 120-130 degrees Fahrenheit.

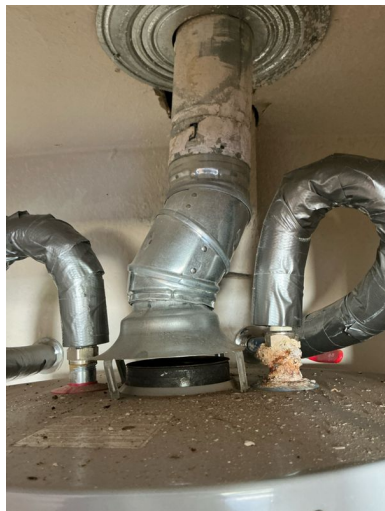
4: Vent - Missing 3 screws

The water heater flue connector should be mechanically attached to the draft hood with a minimum of three sheet metal screws.

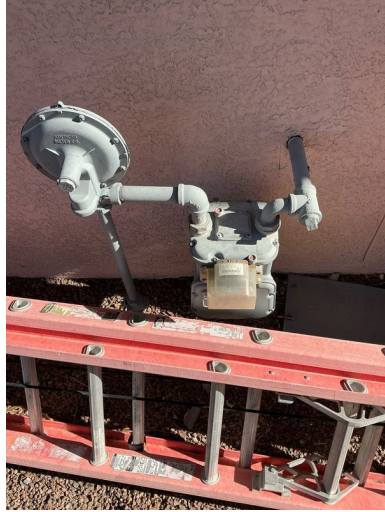
Location of Gas Meter: Right Exterior

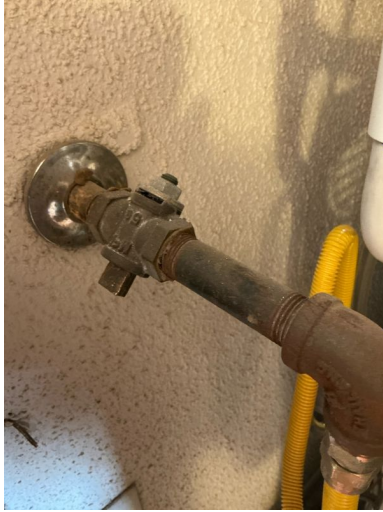
It is recommended that the older spring load gas valves be changed out to the new style ball valves.

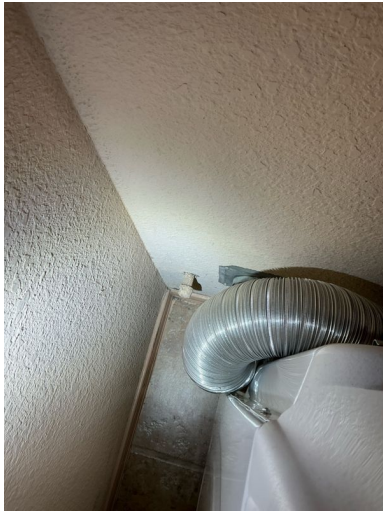
2: Add valve to laundry gas connection

Recommend having a valve installed on dryer gas connection.

Recommendation: Contact a qualified plumbing contractor.

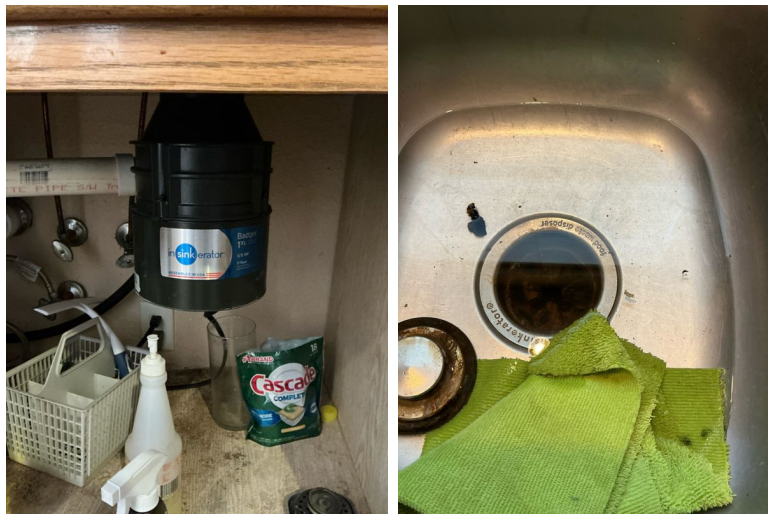
1: Inoperative

The food waste disposer is inoperative.

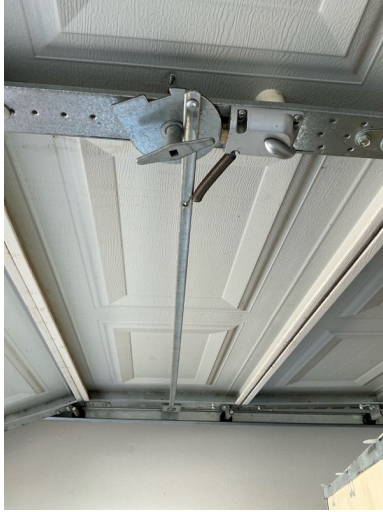
When an automatic garage door opener is in use, the manual lock should be disabled or removed.

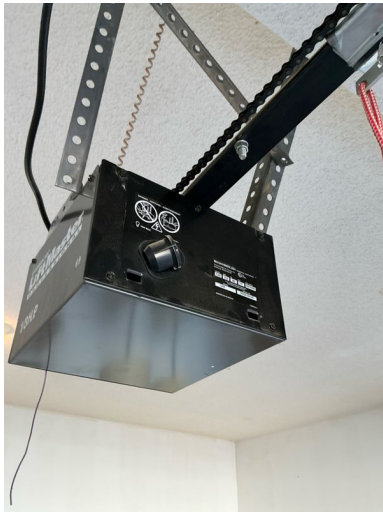
2: Light Inoperative

The garage door light was inoperative at the time of inspection.

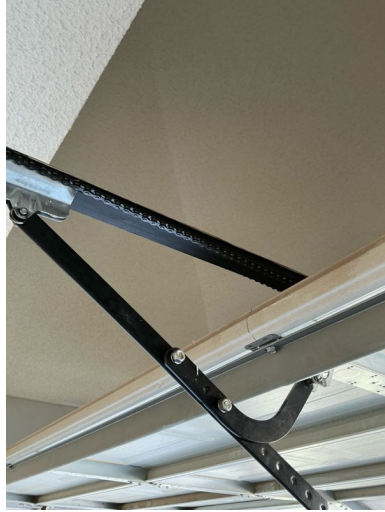
3: Loose Chain

The garage door opener chain is loose and needs to be better secured and/or adjusted.

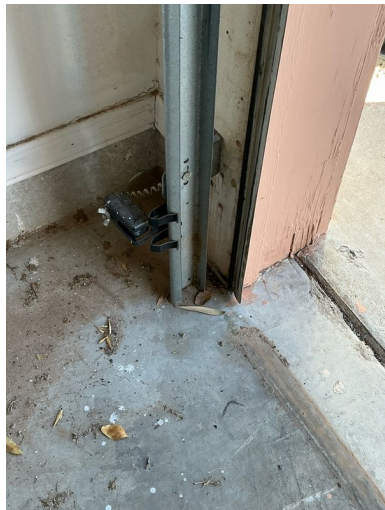
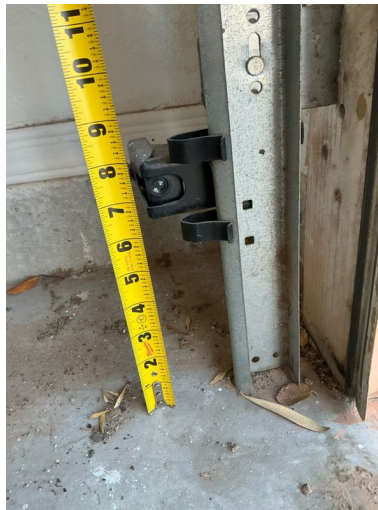
5: Reverse Sensors Too High

4: Resistance Test Failed

The garage door opener DID NOT automatically reverse under reasonable resistance when closing. Improvement may be as simple as adjusting the sensitivity control on the opener.

The garage door reverse sensors are not properly installed. The garage door reverse sensors should be installed within 6-inches of the garage floor.

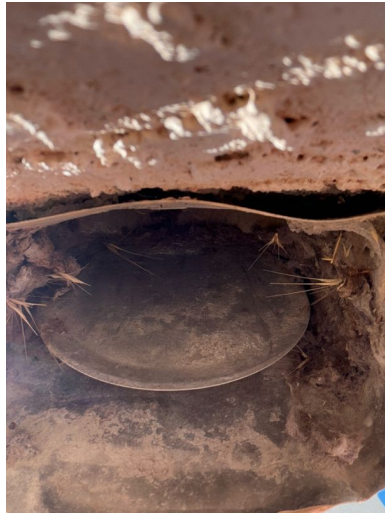
1: Damper Not Functioning

The damper at the dryer exhaust termination does not function properly. The damper does not reset to the closed position when not in use.
